# Access Compliance Report

## Public Rights-of-Way

### (Curb Ramps)

| Intersection ID: N/A | Main Street: CLARKSON_ST | Cross Street: DUNBAR_ST | Location: S |

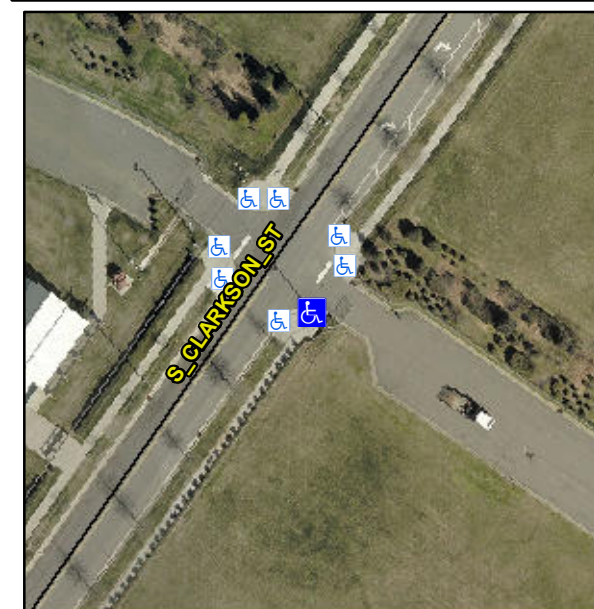
| ADA ID: C836ECE10411 | Ramp Type: Perp | Initial Pass/Fail: Fail | Overall Compliance: No |
| Severity Score: 10 | | | |

**Not Found, R304.5.1, R304.5.3**

| Compliance | Description | Data | Compliance | Description | Data |
|---|---|---|---|---|---|
| N/A | Ramp Length (in) | 95.0 | Yes | Ramp Slope (%) | 6.1 |
| No | Ramp Width (in) | 47.0 | No | Ramp XSlope (%) | 2.4 |

**Remove & Replace Entire Ramp.**

Total Cost: \$ 1850.00
