# Access Compliance Report

## Public Rights-of-Way

### (Curb Ramps)

Intersection ID: 31724	Main Street: FILBERT_LN	Cross Street: PAPER_BIRCH_DR	Location: SW
ADA ID: C838A5766229	Ramp Type: PerpDiag	Initial Pass/Fail: Fail	Overall Compliance: No
		Severity Score: 8.75

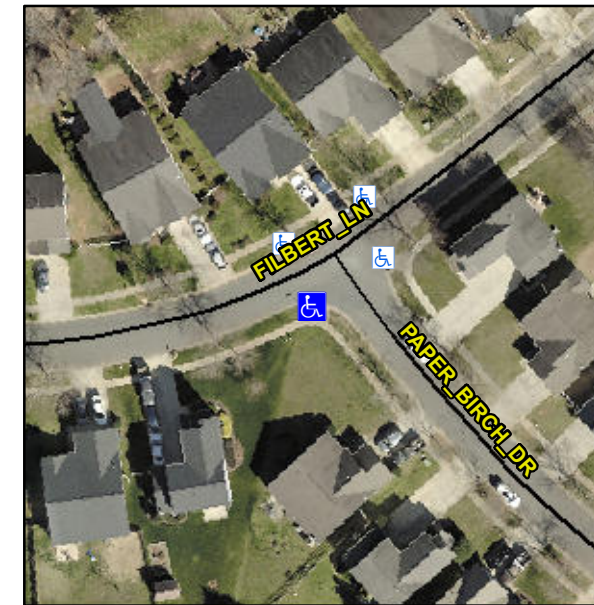
Compliance	Description	Data	Compliance	Description	Data
N/A	Ramp Length (in)	87.0	Yes	Ramp Slope (%)	5.6
No	Ramp Width (in)	37.5	Yes	Ramp XSlope (%)	0.2
N/A	Flare Type LT	N/A	N/A	Flare Type RT	N/A
N/A	Flare Slope LT (%)	N/A	N/A	Flare Slope RT (%)	N/A
N/A	Flare Traversable LT?	N/A	N/A	Flare Traversable RT?	N/A
N/A	Landing Length (in)	N/A	N/A	DWS Provided?	N/A
N/A	Landing Width (in)	N/A	N/A	DWS Contrast?	N/A
N/A	Landing Slope (%)	N/A	N/A	DWS Length (in)	N/A
N/A	Landing X Slope (%)	N/A	N/A	DWS Full Width?	N/A
N/A	Landing Curb? (Y/N)	N/A	N/A	DWS Offset (in)	N/A
N/A	Shared Landing?	N/A			
N/A	Gutter Ponding?	N/A	N/A	Gutter Slope (%)	N/A
N/A	Gutter Lip Ht (in)	N/A	N/A	Gutter X Slope (%)	N/A
N/A	Painted X Walk1?	No	N/A	Painted X Walk2?	No
	X Walk 1 Direction	To NE		X Walk 2 Direction	To NW
N/A	X Walk 1 Width (in)	N/A	N/A	X Walk 2 Width (in)	N/A
	X Walk 1 Slope (%)	3.7		X Walk 2 Slope (%)	1.3
	X Walk 1 X Slope (%)	0.2		X Walk 2 X Slope (%)	2.0

N/A	Ramp inside XWalk1?	N/A	N/A	Ramp inside XWalk2?	N/A
	Road Slope (%)	1.1	N/A	Clear Space?	N/A
	Road X Slope (%)	1.8	N/A	Clear Space to XWalk (in)	N/A
N/A	Any Obstructions?	N/A	N/A	Storm Grate/Utility Hazard?	N/A
	Obstruction Type			Storm Grate/Utility Type	
		N/A			N/A
			Yes	Surface Condition? (G/P)	Good

**Remove & Replace Curb Ramp With Two New Directional Ramps or Equivalent.**

**Not Found, R304.5.1**

Total Cost: \$ 3200.00

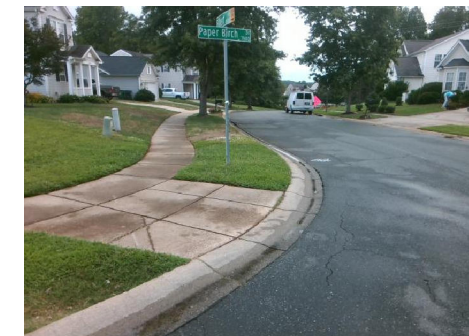
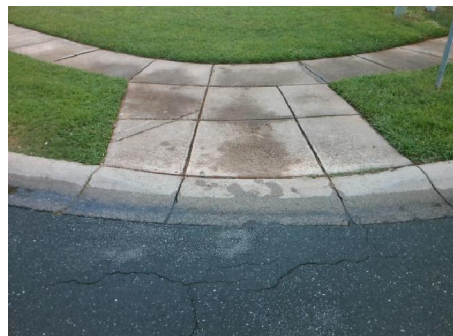
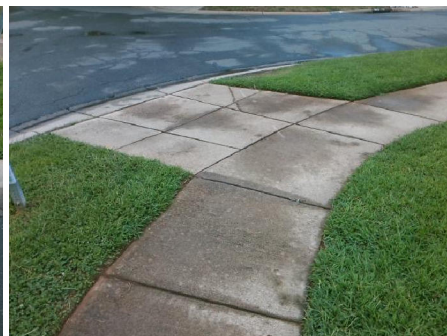
Street 1 Name PAPER BIRCH DR  
 Stop Condition-Street 2 StopSign  
 Street 2 Name FILBERT LN  
 Stop Condition-Street 1 None
