## **Access Compliance Report Public Rights-of-Way** (Curb Ramps)

Intersection ID: 10037026 Main Street: S\_TRYON\_ST Cross Street: N/A Location: NE **Overall Compliance: No** ADA ID: C83B5B76A004 Ramp Type: Perp Initial Pass/Fail: Fail Severity Score: 33.75

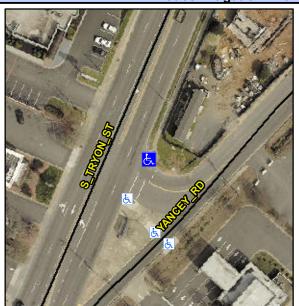
Field Measurements/Component Compliance								
Comp	liance Description	Data	Comp	liance	Description	Data		
N/A	Ramp Length (in)	50.0	No	Ramp	Slope (%)	10.6		
No	Ramp Width (in)	39.0	No	Ramp	XSlope (%)	6.4		
N/A	Flare Type LT	N/A	N/A	Flare	Type RT	N/A		
N/A	Flare Slope LT (%)	N/A	N/A	Flare	Slope RT (%)	N/A		
N/A	Flare Traversable LT?	N/A	N/A	Flare	Traversable RT?	N/A		
N/A	Landing Length (in)	N/A	N/A	DWS	Provided?	N/A		
N/A	Landing Width (in)	N/A	N/A	DWS	Contrast?	N/A		
N/A	Landing Slope (%)	N/A	N/A	DWS	Length (in)	N/A		
N/A	Landing X Slope (%)	N/A	N/A	DWS	Full Width?	N/A		
N/A	Landing Curb? (Y/N)	N/A	N/A	DWS	Offset (in)	N/A		
N/A	Shared Landing?	N/A						
N/A	Gutter Ponding?	N/A	N/A	Gutte	r Slope (%)	N/A		
N/A	Gutter Lip Ht (in)	N/A	N/A	Gutte	r X Slope (%)	N/A		
N/A	Painted X Walk1?	Yes	N/A	Paint	ed X Walk2?	N/A		
	X Walk 1 Direction	To SW		X Wa	lk 2 Direction	N/A		
N/A	X Walk 1 Width (in)	108.0	N/A	X Wa	lk 2 Width (in)	N/A

X Walk 1 Slope (%)	3.9		X Wa	lk 2 Slope (%)	N/A		
	X Walk 1 X Slope (%)	5.7		X Wa	lk 2 X Slope (%)	N/A		
N/A	Ramp inside XWalk1?	Yes	N/A	Ram	inside XWalk2?	N/A		
	Road Slope (%)	N/A	N/A	Clear	Space?	N/A		
	Road X Slope (%)	N/A	N/A	Clear	Space to XWalk (in)	N/A		
N/A	Any Obstructions?	N/A	N/A	Storn	n Grate/Utility Hazard?	N/A		
	Obstruction Type			Storn	n Grate/Utility Type			
		N/A				N/A

Possible Solutions:	<u>c</u>		
Remove & Replace Entire Ramp.			
	N		
	N		
	N		
	N		
	N		
Surveyor Notes:	N		
N/A	N		
	N		
	N		
	N		
PROW/ADA:	N		
R304.5.1, R304.2.2, R304.5.3	N		
, ,	N		
	N		
	N
