# Access Compliance Report

## Public Rights-of-Way

### (Curb Ramps)

| Intersection ID: 49276 | Main Street: HOMECOMING_WY | Cross Street: REUNION_ST | Location: SW |

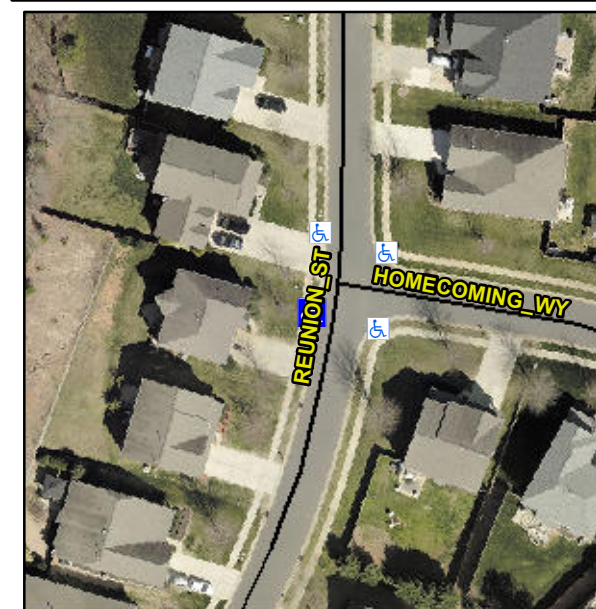
| ADA ID: C83C620BB56F | Ramp Type: Perp | Initial Pass/Fail: Pass | Overall Compliance: No |
| Severity Score: 0.25 | | | |

| Compliance | Description | Data | Compliance | Description | Data |
|---|---|---|---|---|---|
| No | Landing Length (in) | 45.0 | Yes | DWS Provided? | Yes |
| No | Landing Slope (%) | 2.1 | Yes | DWS Length (in) | 24.5 |
| No | Landing X Slope (%) | 3.6 | Yes | DWS Full Width? | Yes |
| Yes | Gutter Lip Ht (in) | 0.0 | No | Gutter X Slope (%) | 3.3 |

Possible Solutions:

**Remove & Replace Landing.  
Remove & Replace Gutter.**

**R304.2.1, R304.2.2-Perp, R304.3.2-  
Para, R304.5.3**

Total Cost: \$ 1250.00
