# Access Compliance Report

## Public Rights-of-Way

### (Curb Ramps)

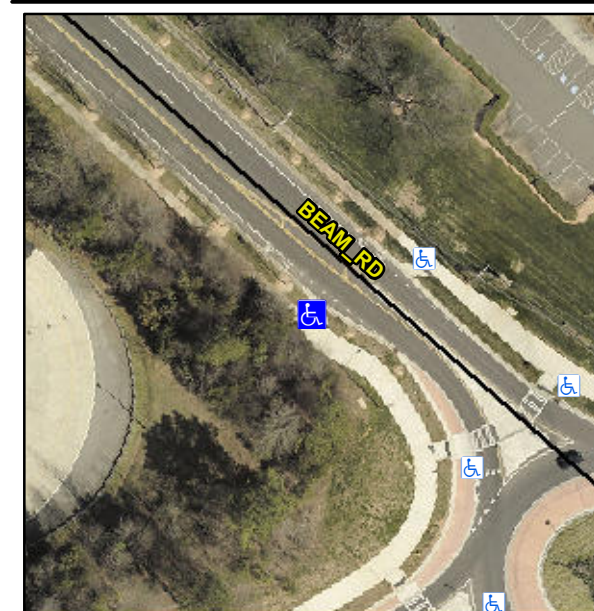
Intersection ID: 10020687	Main Street: BEAM_RD	Cross Street: N/A	Location: W
ADA ID: C84A29B10783	Ramp Type: Perp	Initial Pass/Fail: Fail	Overall Compliance: No
Severity Score: 12.5			
Codes/Mitigation Info/Possible Solution		Field Measurements/Component Compliance

Compliance	Description	Data	Compliance	Description	Data
N/A	Ramp Length (in)	91.0	No	Ramp Slope (%)	8.6
Yes	Ramp Width (in)	92.0	Yes	Ramp XSlope (%)	0.9
N/A	Flare Type LT	N/A	N/A	Flare Type RT	N/A
N/A	Flare Slope LT (%)	N/A	N/A	Flare Slope RT (%)	N/A
N/A	Flare Traversable LT?	N/A	N/A	Flare Traversable RT?	N/A
N/A	Landing Length (in)	N/A	N/A	DWS Provided?	N/A
N/A	Landing Width (in)	N/A	N/A	DWS Contrast?	N/A
N/A	Landing Slope (%)	N/A	N/A	DWS Length (in)	N/A
N/A	Landing X Slope (%)	N/A	N/A	DWS Full Width?	N/A
N/A	Landing Curb? (Y/N)	N/A	N/A	DWS Offset (in)	N/A
N/A	Shared Landing?	N/A			
N/A	Gutter Ponding?	N/A	N/A	Gutter Slope (%)	N/A
N/A	Gutter Lip Ht (in)	N/A	N/A	Gutter X Slope (%)	N/A
N/A	Painted X Walk1?	No	N/A	Painted X Walk2?	N/A
	X Walk 1 Direction	To E		X Walk 2 Direction	N/A
N/A	X Walk 1 Width (in)	N/A	N/A	X Walk 2 Width (in)	N/A
	X Walk 1 Slope (%)	4.2		X Walk 2 Slope (%)	N/A
	X Walk 1 X Slope (%)	0.6		X Walk 2 X Slope (%)	N/A

N/A	Ramp inside XWalk1?	N/A	N/A	Ramp inside XWalk2?	N/A
	Road Slope (%)	N/A	N/A	Clear Space?	N/A
	Road X Slope (%)	N/A	N/A	Clear Space to XWalk (in)	N/A
N/A	Any Obstructions?	N/A	N/A	Storm Grate/Utility Hazard?	N/A
	Obstruction Type			Storm Grate/Utility Type	
		N/A			N/A
		Yes		Surface Condition? (G/P)	Good

Possible Solutions:

**Remove & Replace Entire Ramp.**

**Not Found, R304.2.2**
