# Access Compliance Report

## Public Rights-of-Way

| Intersection ID: 44760 | Main Street: KINGS_PARADE_BV | Cross Street: OBAN_PASSAGE_DR | Location: SE |
| ADA ID: C8522D08544D | Ramp Type: BlendTrans1 | Initial Pass/Fail: Fail | Overall Compliance: No |

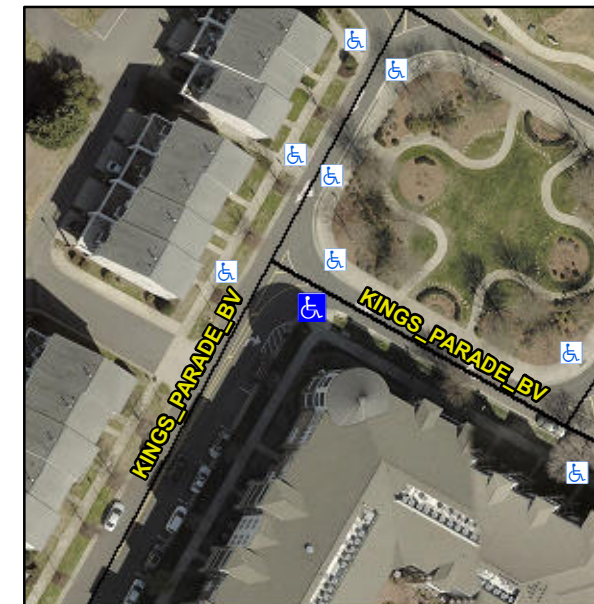
| Severity Score: 8.75 | | | |

**Not Found, R304.5.1**

| Compliance | Description | Data | Compliance | Description | Data |
|---|---|---|---|---|---|
| No | Ramp Width (in) | 45.5 | Yes | BlendTrans XSlope (%) | 1.9 |
| | | | No | Curb Slope (%) | 16.0 |

**Remove & Replace Curb Ramp With Two New Directional Ramps or Equivalent.**

Total Cost: \$ 3200.00
