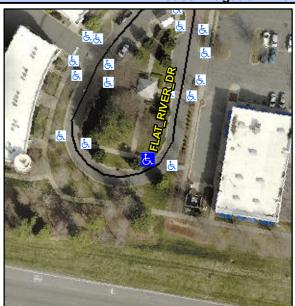
Intersection ID: 1001734Main Street:FLAT_RIVER_DRCross Street:OVERLAND_PARK_LNLocation:WADA ID: C85424F9B9D9Ramp Type:PerpInitial Pass/Fail:FailOverall Compliance:NoSeverity Score:13.75

Comp	liance Description	Data		liance Description	Data
N/A	Ramp Length (in)	45.0	No	Ramp Slope (%)	10.9
Yes	Ramp Width (in)	48.0	No	Ramp XSlope (%)	2.2
N/A	Flare Type LT	N/A	N/A	Flare Type RT	N/A
N/A	Flare Slope LT (%)	N/A	N/A	Flare Slope RT (%)	N/A
N/A	Flare Traversable LT?	N/A	N/A	Flare Traversable RT?	N/A
N/A	Landing Length (in)	N/A	N/A	DWS Provided?	N/A
N/A	Landing Width (in)	N/A	N/A	DWS Contrast?	N/A
N/A	Landing Slope (%)	N/A	N/A	DWS Length (in)	N/A
N/A	Landing X Slope (%)	N/A	N/A	DWS Full Width?	N/A
N/A	Landing Curb? (Y/N)	N/A	N/A	DWS Offset (in)	N/A
N/A	Shared Landing?	N/A			
N/A	Gutter Ponding?	N/A	N/A	Gutter Slope (%)	N/A
N/A	Gutter Lip Ht (in)	N/A	N/A	Gutter X Slope (%)	N/A
N/A	Painted X Walk1?	Yes	N/A	Painted X Walk2?	N/A
	X Walk 1 Direction	То Е		X Walk 2 Direction	N/A
N/A	X Walk 1 Width (in)	51.0	N/A	X Walk 2 Width (in)	N/A
	X Walk 1 Slope (%)	2.4		X Walk 2 Slope (%)	N/A
	X Walk 1 X Slope (%)	0.7		X Walk 2 X Slope (%)	N/A

CCCIDIO CCIALICII	
Possible Solutions:	Com
Remove & Replace Entire Ramp.	N/A
•	Yes
	N/A
	N/A
	N/A
	N/A
Surveyor Notes:	N/A
N/A	N/A
	N/A
	N/A
	N/A
PROW/ADA:	N/A
R304.2.2, R304.5.3	N/A
	N/A
	N/A
	N/A
