Intersection ID: 10014161	Main Street: MARKET_ST	Cross Street: N/A	Location:	E
ADA ID: C8590521736E	Ramp Type: Perp	Initial Pass/Fail: Pass	Overall Compliance: No	Severity Score: 5

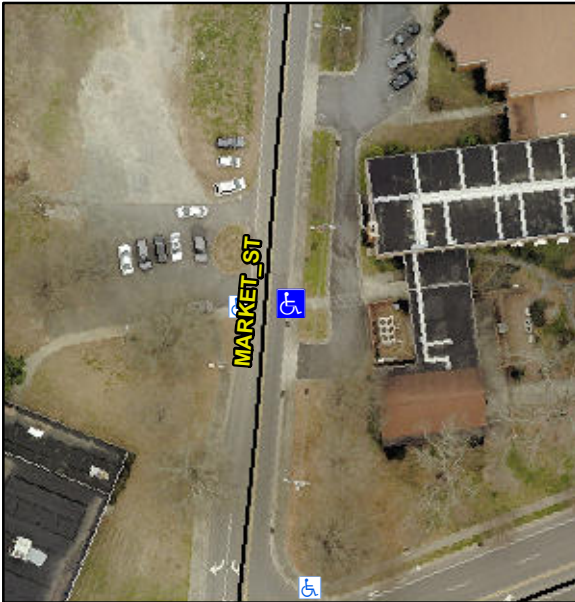
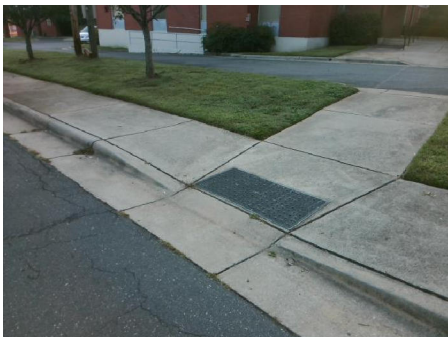
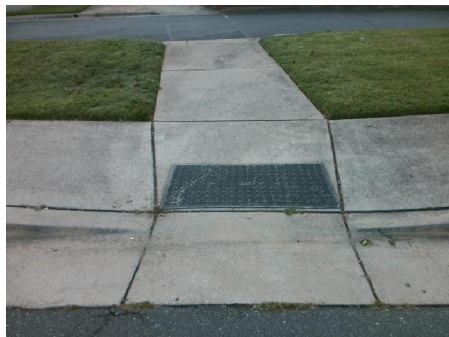
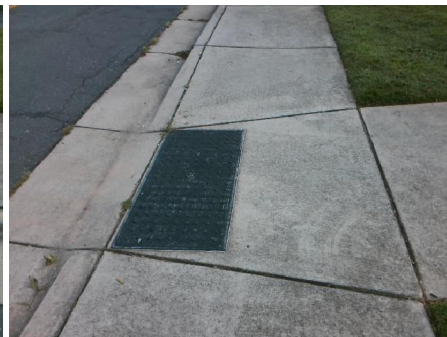
MARKET ST

Not Found, R304.2.2-Perp, R304.3.2-Para, R304.5.3, R304.5.4

Compliance	Description	Data	Compliance	Description	Data
N/A	Ramp Length (in)	61.0	Yes	Ramp Slope (%)	5.3
Yes	Ramp Width (in)	48.0	Yes	Ramp XSlope (%)	1.7
N/A	Flare Type LT	Sloped	N/A	Flare Type RT	N/A
N/A	Flare Slope LT (%)	2.5	N/A	Flare Slope RT (%)	7.2
N/A	Flare Traversable LT?	No	N/A	Flare Traversable RT?	No
Yes	Landing Length (in)	75.0	Yes	DWS Provided?	Yes
Yes	Landing Width (in)	70.5	Yes	DWS Contrast?	Yes
No	Landing Slope (%)	5.6	Yes	DWS Length (in)	24.0
No	Landing X Slope (%)	2.6	Yes	DWS Full Width?	Yes
N/A	Landing Curb? (Y/N)	No	Yes	DWS Offset (in)	1.0
N/A	Shared Landing?	Yes			
Yes	Gutter Ponding?	No	No	Gutter Slope (%)	8.8
Yes	Gutter Lip Ht (in)	0.0	Yes	Gutter X Slope (%)	1.9
N/A	Painted X Walk1?	No	N/A	Painted X Walk2?	N/A
	X Walk 1 Direction	To W		X Walk 2 Direction	N/A
N/A	X Walk 1 Width (in)	N/A	N/A	X Walk 2 Width (in)	N/A
	X Walk 1 Slope (%)	2.7		X Walk 2 Slope (%)	N/A
	X Walk 1 X Slope (%)	2.6		X Walk 2 X Slope (%)	N/A

N/A	Ramp inside XWalk1?	N/A	N/A	Ramp inside XWalk2?	N/A
	Road Slope (%)	N/A	N/A	Clear Space?	Yes
	Road X Slope (%)	N/A	N/A	Clear Space to XWalk (in)	N/A
Yes	Any Obstructions?	No	Yes	Storm Grate/Utility Hazard?	No
	Obstruction Type			Storm Grate/Utility Type	
		N/A			N/A
			Yes	Surface Condition? (G/P)	Good

**Remove & Replace Entire Ramp.
Remove & Replace Gutter.**
