Access Compliance Report

Public Rights-of-Way

(Curb Ramps)

| Intersection ID: 51045 | Main Street: PALATINE_LN | Cross Street: KENDALL_DR | Location: SW |

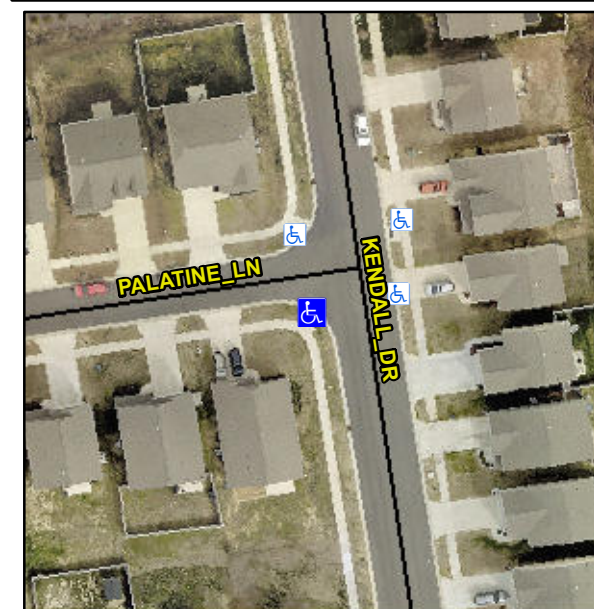
| Compliance | Description | Data | Compliance | Description | Data |
|---|---|---|---|---|---|
| Yes | Ramp Width (in) | 59.0 | No | Ramp XSlope (%) | 2.1 |
| N/A | Landing Curb? (Y/N) | No | No | DWS Offset (in) | 3.5 |
| Yes | Gutter Lip Ht (in) | 0.0 | No | Gutter X Slope (%) | 3.0 |

Remove & Replace Curb Ramp With Two New Directional Ramps or Equivalent. Remove & Replace Gutter.
