Access Compliance Report

Public Rights-of-Way

(Curb Ramps)

Intersection ID: 1001290	Main Street: DAVID_TAYLOR_DR	Cross Street: DAVID_TAYLOR_DR	Location: SE
ADA ID: C878A5BA6517	Ramp Type: MedianPerp	Initial Pass/Fail: Fail	Overall Compliance: No
Codes/Mitigation Info/Possible Solution		Field Measurements/Component Compliance

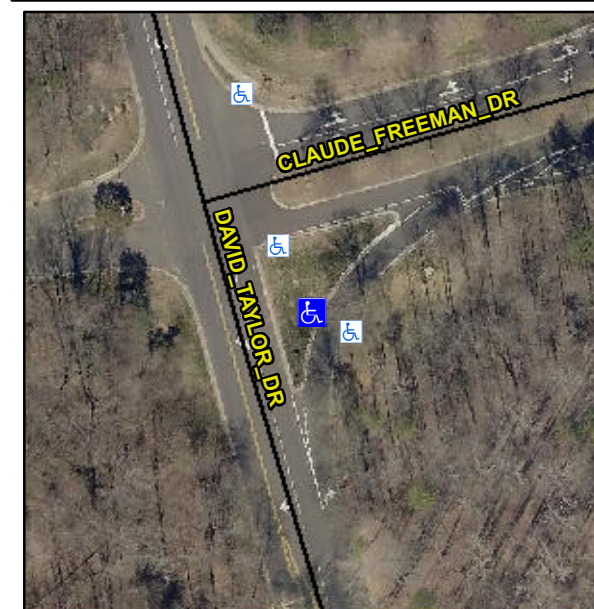
R304.2.2, R304.5.3

Compliance	Description	Data	Compliance	Description	Data
N/A	Ramp Length (in)	58.5	No	Ramp Slope (%)	10.2
Yes	Ramp Width (in)	48.0	No	Ramp XSlope (%)	5.8
N/A	Flare Type LT	N/A	N/A	Flare Type RT	N/A
N/A	Flare Slope LT (%)	N/A	N/A	Flare Slope RT (%)	N/A
N/A	Flare Traversable LT?	N/A	N/A	Flare Traversable RT?	N/A
N/A	Landing Length (in)	N/A	N/A	DWS Provided?	N/A
N/A	Landing Width (in)	N/A	N/A	DWS Contrast?	N/A
N/A	Landing Slope (%)	N/A	N/A	DWS Length (in)	N/A
N/A	Landing X Slope (%)	N/A	N/A	DWS Full Width?	N/A
N/A	Landing Curb? (Y/N)	N/A	N/A	DWS Offset (in)	N/A
N/A	Shared Landing?	N/A			
N/A	Gutter Ponding?	N/A	N/A	Gutter Slope (%)	N/A
N/A	Gutter Lip Ht (in)	N/A	N/A	Gutter X Slope (%)	N/A
N/A	Painted X Walk1?	No	N/A	Painted X Walk2?	N/A
	X Walk 1 Direction	To SE		X Walk 2 Direction	N/A
N/A	X Walk 1 Width (in)	N/A	N/A	X Walk 2 Width (in)	N/A
	X Walk 1 Slope (%)	2.7		X Walk 2 Slope (%)	N/A
	X Walk 1 X Slope (%)	7.2		X Walk 2 X Slope (%)	N/A

Remove & Replace Entire Ramp.

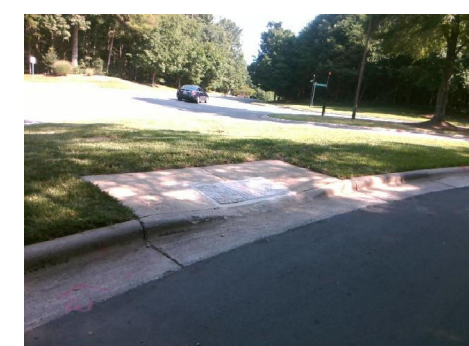
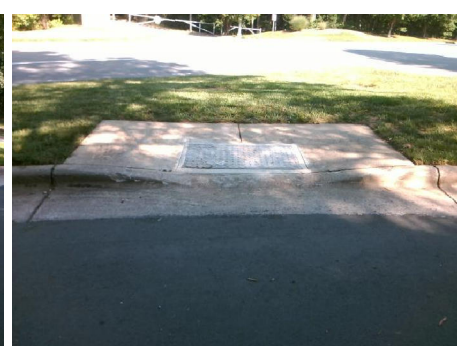
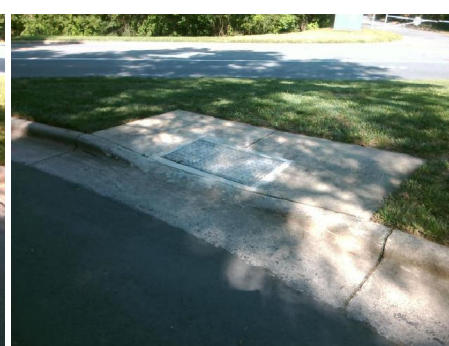
N/A	Ramp inside XWalk1?	N/A	N/A	Ramp inside XWalk2?	N/A
	Road Slope (%)	N/A	N/A	Clear Space?	N/A
	Road X Slope (%)	N/A	N/A	Clear Space to XWalk (in)	N/A
N/A	Any Obstructions?	N/A	N/A	Storm Grate/Utility Hazard?	N/A
	Obstruction Type			Storm Grate/Utility Type	
		N/A			N/A
			Yes	Surface Condition? (G/P)	Good
