Access Compliance Report

Public Rights-of-Way

(Curb Ramps)

Intersection ID: 28655	Main Street: HAMPTON_PLACE_DR	Cross Street: KEELS_CT	Location:	NW
ADA ID: C87FED47DBA9	Ramp Type: BlendTrans1	Initial Pass/Fail: Fail	Overall Compliance: No	Severity Score: 10
Codes/Mitigation Info/Possible Solution		Field Measurements/Component Compliance

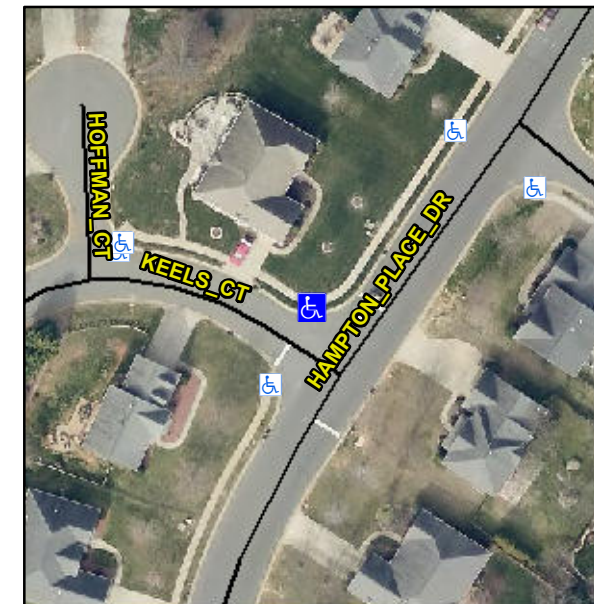
Compliance	Description	Data	Compliance	Description	Data
N/A	Ramp Length (in)	51.0	Yes	BlendTrans Slope (%)	4.8
No	Ramp Width (in)	47.4	No	BlendTrans XSlope (%)	2.4
N/A	Flare Type LT	N/A	N/A	Flare Type RT	N/A
N/A	Flare Slope LT (%)	N/A	N/A	Flare Slope RT (%)	N/A
N/A	Flare Traversable LT?	N/A	N/A	Flare Traversable RT?	N/A
N/A	Landing Length (in)	N/A	N/A	DWS Provided?	N/A
N/A	Landing Width (in)	N/A	N/A	DWS Contrast?	N/A
N/A	Landing Slope (%)	N/A	N/A	DWS Length (in)	N/A
N/A	Landing X Slope (%)	N/A	N/A	DWS Full Width?	N/A
N/A	Landing Curb? (Y/N)	N/A	N/A	DWS Offset (in)	N/A
N/A	Shared Landing?	N/A			
N/A	Gutter Ponding?	N/A	N/A	Gutter Slope (%)	N/A
N/A	Gutter Lip Ht (in)	N/A	N/A	Gutter X Slope (%)	N/A
N/A	Painted X Walk1?	No	N/A	Painted X Walk2?	N/A
	X Walk 1 Direction	To SW		X Walk 2 Direction	N/A
	X Walk 1 Width (in)	N/A		X Walk 2 Width (in)	N/A
	X Walk 1 Slope (%)	1.6		X Walk 2 Slope (%)	N/A
	X Walk 1 X Slope (%)	0.4		X Walk 2 X Slope (%)	N/A

N/A	Ramp inside XWalk1?	N/A	N/A	Ramp inside XWalk2?	N/A
	Road Slope (%)	0.4		Clear Space?	N/A
	Road X Slope (%)	1.6	N/A	Clear Space to XWalk (in)	N/A
N/A	Any Obstructions?	N/A	N/A	Storm Grate/Utility Hazard?	N/A
	Obstruction Type			Storm Grate/Utility Type	
		N/A			N/A
			Yes	Surface Condition? (G/P)	Good
			N/A	Curb Slope (%)	2.1

Possible Solutions:

Remove & Replace Curb Ramp With Two New Directional Ramps or Equivalent.

R304.5.1, R304.5.3
