Access Compliance Report

Public Rights-of-Way

(Curb Ramps)

Intersection ID: 11049	Main Street: MALTA_PL	Cross Street: OAK_FOREST_DR	Location: W
ADA ID: C88325951458	Ramp Type: Para	Initial Pass/Fail: Fail	Overall Compliance: No
		Severity Score: 25

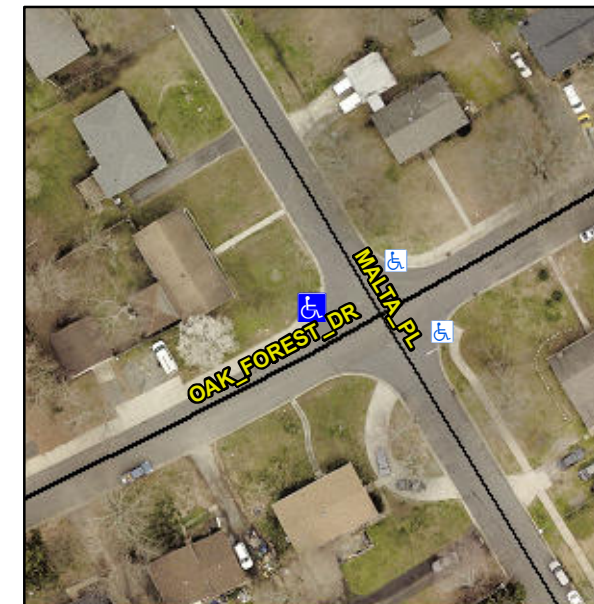
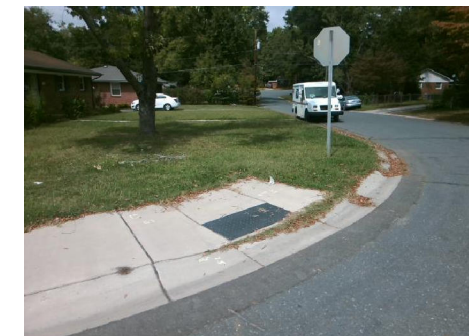
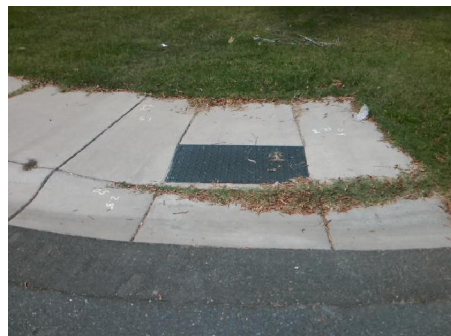
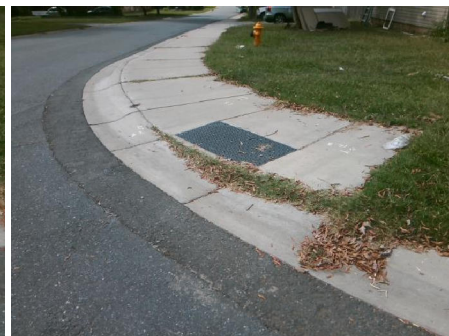
LT RP < 5%

R304.3.2

Compliance	Description	Data	Compliance	Description	Data
N/A	Ramp Length LT (in)	27.0	N/A	Ramp Length RT (in)	29.0
Yes	Ramp Width LT (in)	60.0	Yes	Ramp Width RT (in)	60.0
Yes	Ramp Slope LT (%)	1.5	No	Ramp Slope RT (%)	12.3
Yes	Ramp XSlope LT (%)	1.7	Yes	Ramp XSlope RT (%)	0.4
N/A	Landing Length (in)	N/A	N/A	DWS Provided?	N/A
N/A	Landing Width (in)	N/A	N/A	DWS Contrast?	N/A
N/A	Landing Slope (%)	N/A	N/A	DWS Length (in)	N/A
N/A	Landing X Slope (%)	N/A	N/A	DWS Full Width?	N/A
N/A	Landing Curb? (Y/N)	N/A	N/A	DWS Offset (in)	N/A
N/A	Shared Landing?	N/A			
N/A	Gutter Ponding?	N/A	N/A	Gutter Slope (%)	N/A
N/A	Gutter Lip Ht (in)	N/A	N/A	Gutter X Slope (%)	N/A
N/A	Painted X Walk1?	No	N/A	Painted X Walk2?	N/A
	X Walk 1 Direction	To NE		X Walk 2 Direction	N/A
N/A	X Walk 1 Width (in)	N/A	N/A	X Walk 2 Width (in)	N/A
	X Walk 1 Slope (%)	2.8		X Walk 2 Slope (%)	N/A
	X Walk 1 X Slope (%)	0.5		X Walk 2 X Slope (%)	N/A
N/A	Ramp inside XWalk1?	N/A	N/A	Ramp inside XWalk2?	N/A

Road Slope (%)	N/A	N/A	Clear Space?	N/A
	Road X Slope (%)	N/A	N/A	Clear Space to XWalk (in)	N/A
N/A	Any Obstructions?	N/A	N/A	Storm Grate/Utility Hazard?	N/A
	Obstruction Type			Storm Grate/Utility Type	
		N/A			N/A
			Yes	Surface Condition? (G/P)	Good
			N/A	Curb Slope (%)	5.0

Remove & Replace Entire Ramp.

\$ 1600.00
