Access Compliance Report

Public Rights-of-Way

(Curb Ramps)

Intersection ID: 10020373	Main Street: BALLANTYNE COMMONS PY	Cross Street: N/A	Location: SW
ADA ID: C88BCDDDD623	Ramp Type: BlendTrans1	Initial Pass/Fail: Fail	Overall Compliance: No
		Severity Score: 8.75

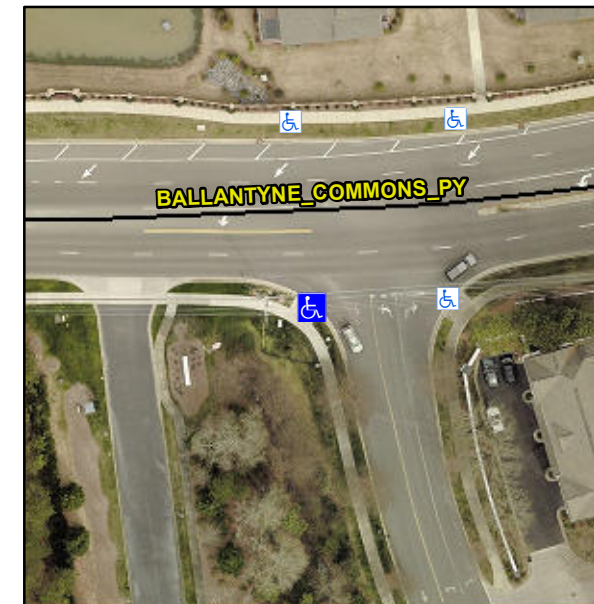
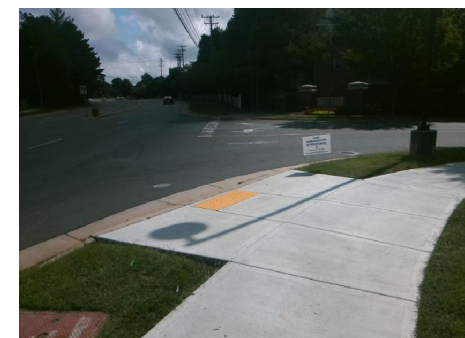
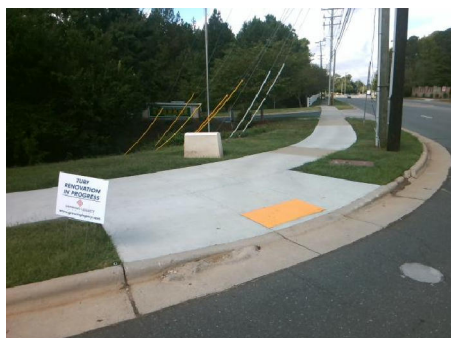
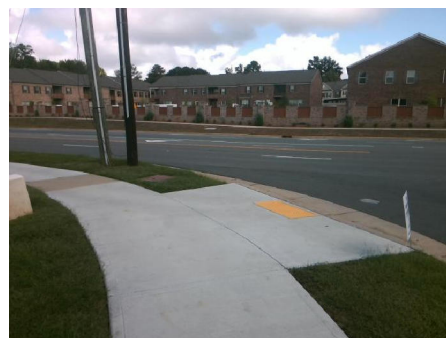
Compliance	Description	Data	Compliance	Description	Data
N/A	Ramp Length (in)	77.0	Yes	BlendTrans Slope (%)	4.2
No	Ramp Width (in)	47.0	Yes	BlendTrans XSlope (%)	0.5
N/A	Flare Type LT	N/A	N/A	Flare Type RT	N/A
N/A	Flare Slope LT (%)	N/A	N/A	Flare Slope RT (%)	N/A
N/A	Flare Traversable LT?	N/A	N/A	Flare Traversable RT?	N/A
N/A	Landing Length (in)	N/A	N/A	DWS Provided?	N/A
N/A	Landing Width (in)	N/A	N/A	DWS Contrast?	N/A
N/A	Landing Slope (%)	N/A	N/A	DWS Length (in)	N/A
N/A	Landing X Slope (%)	N/A	N/A	DWS Full Width?	N/A
N/A	Landing Curb? (Y/N)	N/A	N/A	DWS Offset (in)	N/A
N/A	Shared Landing?	N/A			
N/A	Gutter Ponding?	N/A	N/A	Gutter Slope (%)	N/A
N/A	Gutter Lip Ht (in)	N/A	N/A	Gutter X Slope (%)	N/A
N/A	Painted X Walk1?	No	N/A	Painted X Walk2?	No
	X Walk 1 Direction	To E		X Walk 2 Direction	To N
	X Walk 1 Width (in)	N/A		X Walk 2 Width (in)	N/A
	X Walk 1 Slope (%)	1.6		X Walk 2 Slope (%)	0.3
	X Walk 1 X Slope (%)	0.4		X Walk 2 X Slope (%)	1.0

N/A	Ramp inside XWalk1?	N/A	N/A	Ramp inside XWalk2?	N/A
	Road Slope (%)	1.4		Clear Space?	N/A
	Road X Slope (%)	0.6	N/A	Clear Space to XWalk (in)	N/A
N/A	Any Obstructions?	N/A	N/A	Storm Grate/Utility Hazard?	N/A
	Obstruction Type			Storm Grate/Utility Type	
		N/A			N/A
			Yes	Surface Condition? (G/P)	Good
			N/A	Curb Slope (%)	4.3

Remove & Replace Curb Ramp With Two New Directional Ramps or Equivalent.

R304.5.1
