Access Compliance Report

Public Rights-of-Way

(Curb Ramps)

Intersection ID: 27792	Main Street: BLAKENEY_HEATH_RD	Cross Street: PARKS_FARM_LN	Location: SW
ADA ID: C898C785CC3A	Ramp Type: BlendTrans1	Initial Pass/Fail: Fail	Overall Compliance: No
		Severity Score: 8.75

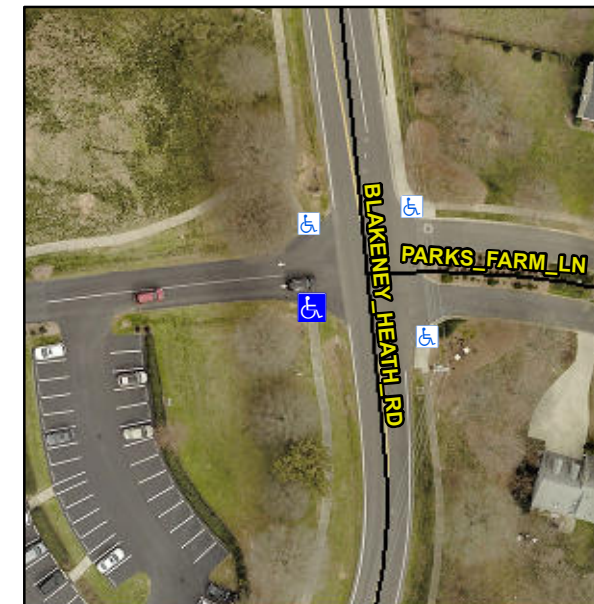
Compliance	Description	Data	Compliance	Description	Data
N/A	Ramp Length (in)	41.0	Yes	BlendTrans Slope (%)	1.8
No	Ramp Width (in)	47.0	Yes	BlendTrans XSlope (%)	1.6
N/A	Flare Type LT	N/A	N/A	Flare Type RT	N/A
N/A	Flare Slope LT (%)	N/A	N/A	Flare Slope RT (%)	N/A
N/A	Flare Traversable LT?	N/A	N/A	Flare Traversable RT?	N/A
N/A	Landing Length (in)	N/A	N/A	DWS Provided?	N/A
N/A	Landing Width (in)	N/A	N/A	DWS Contrast?	N/A
N/A	Landing Slope (%)	N/A	N/A	DWS Length (in)	N/A
N/A	Landing X Slope (%)	N/A	N/A	DWS Full Width?	N/A
N/A	Landing Curb? (Y/N)	N/A	N/A	DWS Offset (in)	N/A
N/A	Shared Landing?	N/A			
N/A	Gutter Ponding?	N/A	N/A	Gutter Slope (%)	N/A
N/A	Gutter Lip Ht (in)	N/A	N/A	Gutter X Slope (%)	N/A
N/A	Painted X Walk1?	No	N/A	Painted X Walk2?	N/A
	X Walk 1 Direction	To N		X Walk 2 Direction	N/A
	X Walk 1 Width (in)	N/A		X Walk 2 Width (in)	N/A
	X Walk 1 Slope (%)	1.7		X Walk 2 Slope (%)	N/A
	X Walk 1 X Slope (%)	2.8		X Walk 2 X Slope (%)	N/A

N/A	Ramp inside XWalk1?	N/A	N/A	Ramp inside XWalk2?	N/A
	Road Slope (%)	2.8		Clear Space?	N/A
	Road X Slope (%)	1.7	N/A	Clear Space to XWalk (in)	N/A
N/A	Any Obstructions?	N/A	N/A	Storm Grate/Utility Hazard?	N/A
	Obstruction Type			Storm Grate/Utility Type	
		N/A			N/A
			Yes	Surface Condition? (G/P)	Good
			N/A	Curb Slope (%)	4.2

Remove & Replace Curb Ramp With Two New Directional Ramps or Equivalent.

R304.5.1
