Access Compliance Report

Public Rights-of-Way

(Curb Ramps)

Intersection ID: 7993	Main Street: AMERON_DR	Cross Street: N_GRAHAM_ST	Location: NE
ADA ID: C89A33888FEB	Ramp Type: Perp	Initial Pass/Fail: Fail	Overall Compliance: No
Severity Score: 25			
Codes/Mitigation Info/Possible Solution		Field Measurements/Component Compliance

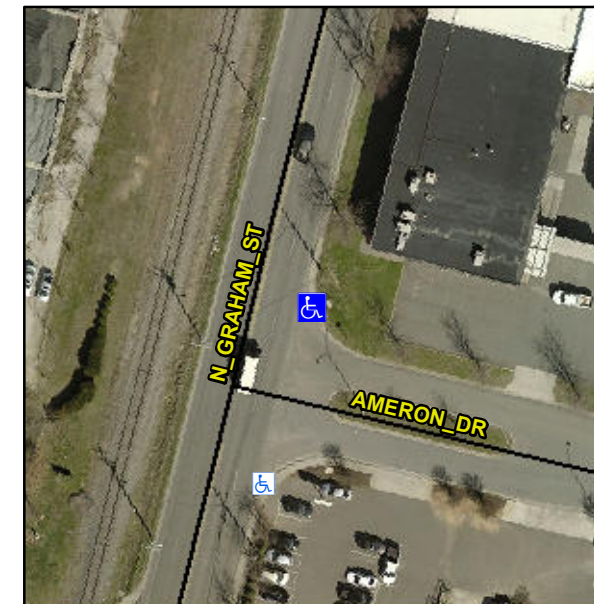
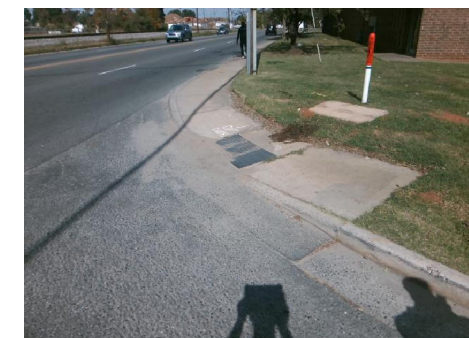
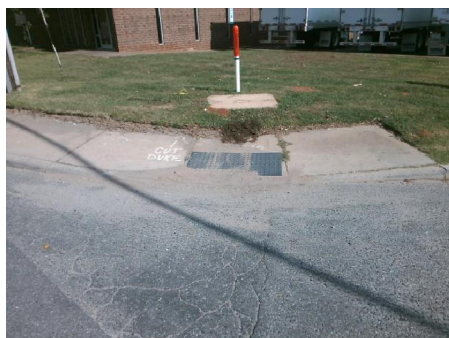
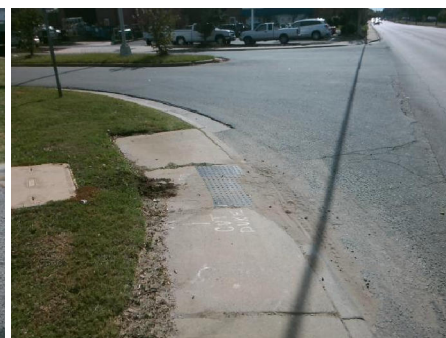
Not Found, R304.2.2

Compliance	Description	Data	Compliance	Description	Data
N/A	Ramp Length (in)	59.5	No	Ramp Slope (%)	12.6
Yes	Ramp Width (in)	50.0	Yes	Ramp XSlope (%)	0.5
N/A	Flare Type LT	N/A	N/A	Flare Type RT	N/A
N/A	Flare Slope LT (%)	N/A	N/A	Flare Slope RT (%)	N/A
N/A	Flare Traversable LT?	N/A	N/A	Flare Traversable RT?	N/A
N/A	Landing Length (in)	N/A	N/A	DWS Provided?	N/A
N/A	Landing Width (in)	N/A	N/A	DWS Contrast?	N/A
N/A	Landing Slope (%)	N/A	N/A	DWS Length (in)	N/A
N/A	Landing X Slope (%)	N/A	N/A	DWS Full Width?	N/A
N/A	Landing Curb? (Y/N)	N/A	N/A	DWS Offset (in)	N/A
N/A	Shared Landing?	N/A			
N/A	Gutter Ponding?	N/A	N/A	Gutter Slope (%)	N/A
N/A	Gutter Lip Ht (in)	N/A	N/A	Gutter X Slope (%)	N/A
N/A	Painted X Walk1?	No	N/A	Painted X Walk2?	N/A
	X Walk 1 Direction	To SW		X Walk 2 Direction	N/A
N/A	X Walk 1 Width (in)	N/A	N/A	X Walk 2 Width (in)	N/A
	X Walk 1 Slope (%)	0.5		X Walk 2 Slope (%)	N/A
	X Walk 1 X Slope (%)	0.7		X Walk 2 X Slope (%)	N/A

N/A	Ramp inside XWalk1?	N/A	N/A	Ramp inside XWalk2?	N/A
	Road Slope (%)	N/A	N/A	Clear Space?	N/A
	Road X Slope (%)	N/A	N/A	Clear Space to XWalk (in)	N/A
N/A	Any Obstructions?	N/A	N/A	Storm Grate/Utility Hazard?	N/A
	Obstruction Type			Storm Grate/Utility Type	
		N/A			N/A
			Yes	Surface Condition? (G/P)	Good

Remove & Replace Entire Ramp.
