# Access Compliance Report

## Public Rights-of-Way

### (Curb Ramps)

Intersection ID: 5104	Main Street: E_MALLARD_CREEK_CHURCH_RD	Cross Street: MARY_ALEXANDER_RD	Location: E
ADA ID: C89B96A81BF3	Ramp Type: Perp	Initial Pass/Fail: Fail	Overall Compliance: No
Severity Score: 21.25			
Codes/Mitigation Info/Possible Solution		Field Measurements/Component Compliance

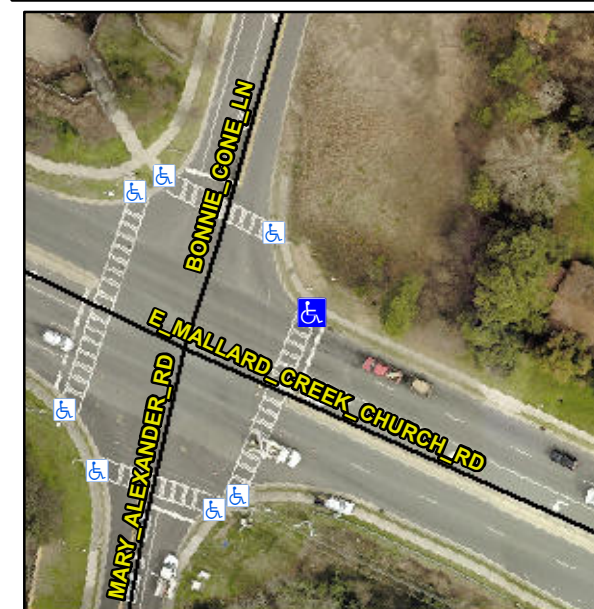
**R304.5.1, R304.2.2**

Compliance	Description	Data	Compliance	Description	Data
N/A	Ramp Length (in)	72.0	No	Ramp Slope (%)	8.5
No	Ramp Width (in)	46.0	Yes	Ramp XSlope (%)	0.3
N/A	Flare Type LT	N/A	N/A	Flare Type RT	N/A
N/A	Flare Slope LT (%)	N/A	N/A	Flare Slope RT (%)	N/A
N/A	Flare Traversable LT?	N/A	N/A	Flare Traversable RT?	N/A
N/A	Landing Length (in)	N/A	N/A	DWS Provided?	N/A
N/A	Landing Width (in)	N/A	N/A	DWS Contrast?	N/A
N/A	Landing Slope (%)	N/A	N/A	DWS Length (in)	N/A
N/A	Landing X Slope (%)	N/A	N/A	DWS Full Width?	N/A
N/A	Landing Curb? (Y/N)	N/A	N/A	DWS Offset (in)	N/A
N/A	Shared Landing?	N/A			
N/A	Gutter Ponding?	N/A	N/A	Gutter Slope (%)	N/A
N/A	Gutter Lip Ht (in)	N/A	N/A	Gutter X Slope (%)	N/A
N/A	Painted X Walk1?	Yes	N/A	Painted X Walk2?	N/A
	X Walk 1 Direction	To SW		X Walk 2 Direction	N/A
N/A	X Walk 1 Width (in)	114.0	N/A	X Walk 2 Width (in)	N/A
	X Walk 1 Slope (%)	3.0		X Walk 2 Slope (%)	N/A
	X Walk 1 X Slope (%)	2.1		X Walk 2 X Slope (%)	N/A

N/A	Ramp inside XWalk1?	Yes	N/A	Ramp inside XWalk2?	N/A
	Road Slope (%)	N/A	N/A	Clear Space?	N/A
	Road X Slope (%)	N/A	N/A	Clear Space to XWalk (in)	N/A
N/A	Any Obstructions?	N/A	N/A	Storm Grate/Utility Hazard?	N/A
	Obstruction Type			Storm Grate/Utility Type	
		N/A			N/A
			Yes	Surface Condition? (G/P)	Good

Possible Solutions:

**Remove & Replace Entire Ramp.**

Total Cost: \$ 1850.00
