Access Compliance Report

Public Rights-of-Way

(Curb Ramps)

Intersection ID: 48942	Main Street: MITCHELL GRANT WY	Cross Street: MORGAN LEE AV	Location: S
ADA ID: C89CF9AFD75E	Ramp Type: Combination1	Initial Pass/Fail: Fail	Overall Compliance: No
Severity Score: 21.25			
Codes/Mitigation Info/Possible Solution		Field Measurements/Component Compliance

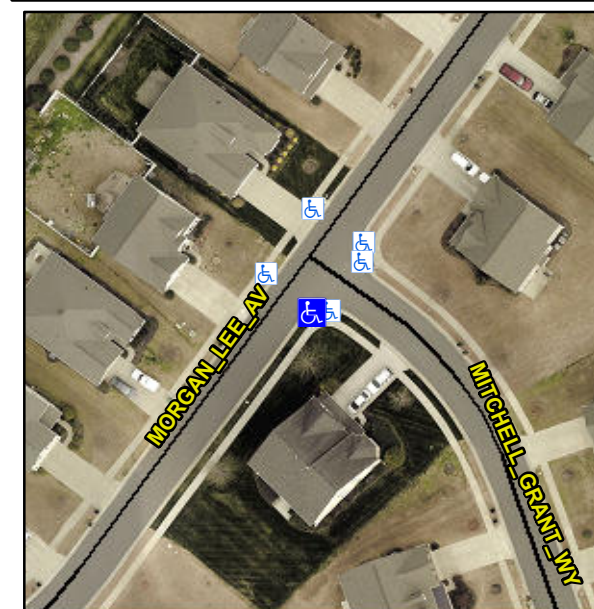
Not Found, R304.5.1, R304.5.1, R304.5.3

Compliance	Description	Data	Compliance	Description	Data
N/A	Ramp Length LT (in)	4.5	N/A	Ramp Length RT (in)	2.5
No	Ramp Width LT (in)	44.5	Yes	Ramp Width RT (in)	48.5
Yes	Ramp Slope LT (%)	6.2	Yes	Ramp Slope RT (%)	6.2
No	Ramp XSlope LT (%)	3.6	No	Ramp XSlope RT (%)	5.9
N/A	Ramp Length (in)	47.0	Yes	Ramp Slope (%)	6.3
No	Ramp Width (in)	47.0	No	Ramp XSlope (%)	5.8
N/A	Flare Type LT	N/A	N/A	Flare Type RT	N/A
N/A	Flare Slope LT (%)	N/A	N/A	Flare Slope RT (%)	N/A
N/A	Flare Traversable LT?	N/A	N/A	Flare Traversable RT?	N/A
N/A	Landing Length (in)	N/A	N/A	DWS Provided?	N/A
N/A	Landing Width (in)	N/A	N/A	DWS Contrast?	N/A
N/A	Landing Slope (%)	N/A	N/A	DWS Length (in)	N/A
N/A	Landing X Slope (%)	N/A	N/A	DWS Full Width?	N/A
N/A	Landing Curb? (Y/N)	N/A	N/A	DWS Offset (in)	N/A
N/A	Shared Landing?	N/A			
N/A	Gutter Ponding?	N/A	N/A	Gutter Slope (%)	N/A
N/A	Gutter Lip Ht (in)	N/A	N/A	Gutter X Slope (%)	N/A
N/A	Painted X Walk1?	No	N/A	Painted X Walk2?	N/A

Remove & Replace Entire Ramp.

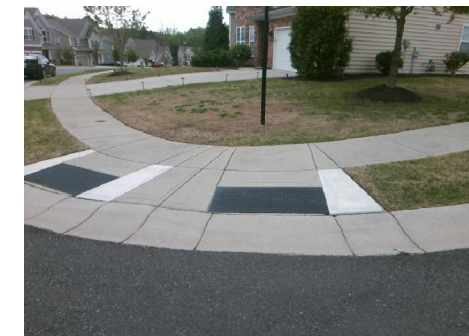
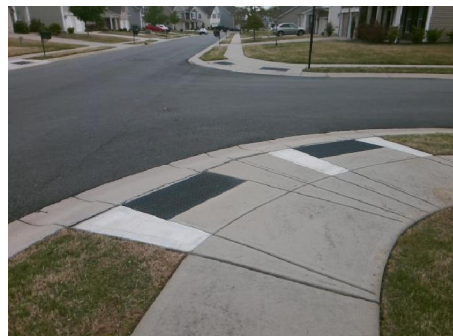
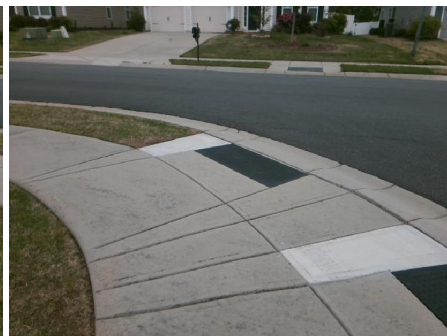
X Walk 1 Direction	To NW		X Walk 2 Direction	N/A
	X Walk 1 Width (in)	N/A		X Walk 2 Width (in)	N/A
	X Walk 1 Slope (%)	2.3		X Walk 2 Slope (%)	N/A
	X Walk 1 X Slope (%)	1.4		X Walk 2 X Slope (%)	N/A
N/A	Ramp inside XWalk1?	N/A	N/A	Ramp inside XWalk2?	N/A
	Road Slope (%)	N/A		Clear Space?	N/A
	Road X Slope (%)	N/A	N/A	Clear Space to XWalk (in)	N/A
			N/A	Any Obstruction?	N/A
				Obstruction Type	N/A
			N/A	Storm Grate/Utility Hazard?	N/A
				Storm Grate/Utility Type	N/A
			Yes	Surface Condition? (G/P)	Good
				Curb Slope (%)	21.9
