Access Compliance Report

Public Rights-of-Way

(Curb Ramps)

Intersection ID: 45517	Main Street: BUGGY_HORSE_RD	Cross Street: MEADOW_BOTTOM_RD	Location: W
ADA ID: C8A4C12CF0B8	Ramp Type: Combination1Diag	Initial Pass/Fail: Fail	Overall Compliance: No
Severity Score: 0			
Codes/Mitigation Info/Possible Solution		Field Measurements/Component Compliance

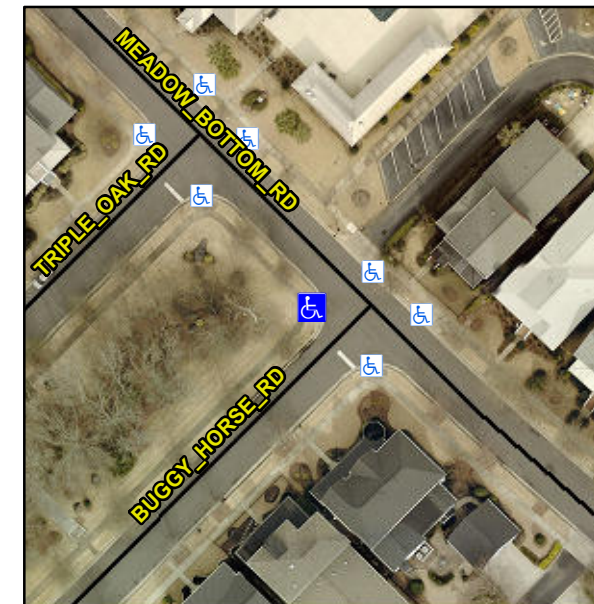
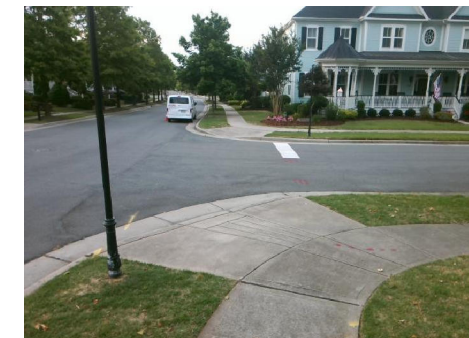
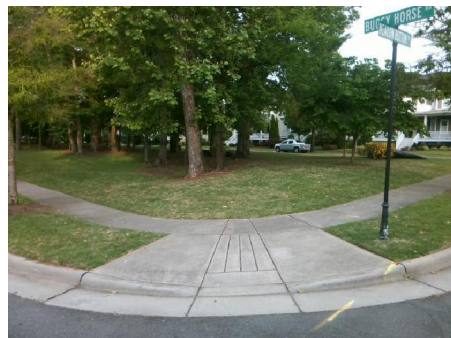
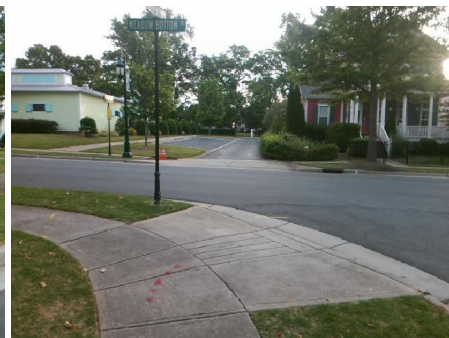
Not Found, R304.5.1, R304.2.2, R304.5.3, R304.3.2

Compliance	Description	Data	Compliance	Description	Data
N/A	Ramp Length LT (in)	24.5	N/A	Ramp Length RT (in)	33.0
Yes	Ramp Width LT (in)	49.0	Yes	Ramp Width RT (in)	48.0
No	Ramp Slope LT (%)	8.7	No	Ramp Slope RT (%)	11.5
No	Ramp XSlope LT (%)	3.0	Yes	Ramp XSlope RT (%)	2.0
N/A	Ramp Length (in)	76.0	No	Ramp Slope (%)	10.0
No	Ramp Width (in)	27.0	No	Ramp XSlope (%)	8.4
N/A	Flare Type LT	N/A	N/A	Flare Type RT	N/A
N/A	Flare Slope LT (%)	N/A	N/A	Flare Slope RT (%)	N/A
N/A	Flare Traversable LT?	N/A	N/A	Flare Traversable RT?	N/A
N/A	Landing Length (in)	N/A	N/A	DWS Provided?	N/A
N/A	Landing Width (in)	N/A	N/A	DWS Contrast?	N/A
N/A	Landing Slope (%)	N/A	N/A	DWS Length (in)	N/A
N/A	Landing X Slope (%)	N/A	N/A	DWS Full Width?	N/A
N/A	Landing Curb? (Y/N)	N/A	N/A	DWS Offset (in)	N/A
N/A	Shared Landing?	N/A			
N/A	Gutter Ponding?	N/A	N/A	Gutter Slope (%)	N/A
N/A	Gutter Lip Ht (in)	N/A	N/A	Gutter X Slope (%)	N/A
N/A	Painted X Walk1?	No	N/A	Painted X Walk2?	No

X Walk 1 Direction	To SE		X Walk 2 Direction	To NE
	X Walk 1 Width (in)	N/A		X Walk 2 Width (in)	N/A
	X Walk 1 Slope (%)	3.0		X Walk 2 Slope (%)	5.4
	X Walk 1 X Slope (%)	5.4		X Walk 2 X Slope (%)	2.9
N/A	Ramp inside XWalk1?	N/A	N/A	Ramp inside XWalk2?	N/A
	Road Slope (%)	4.4		Clear Space?	N/A
	Road X Slope (%)	1.8	N/A	Clear Space to XWalk (in)	N/A
			N/A	Any Obstruction?	N/A
				Obstruction Type	N/A
			N/A	Storm Grate/Utility Hazard?	N/A
				Storm Grate/Utility Type	N/A
			Yes	Surface Condition? (G/P)	Good
				Curb Slope (%)	12.2

Remove & Replace Curb Ramp With Two New Directional Ramps or Equivalent.
