Access Compliance Report

Public Rights-of-Way

(Curb Ramps)

Intersection ID: 20314	Main Street: COLONY_RD	Cross Street: MORROCROFT_FARMS_LN	Location: NW
ADA ID: C8AF89B67BD1	Ramp Type: Directional1	Initial Pass/Fail: Fail	Overall Compliance: No
Severity Score: 13.75			
Codes/Mitigation Info/Possible Solution		Field Measurements/Component Compliance

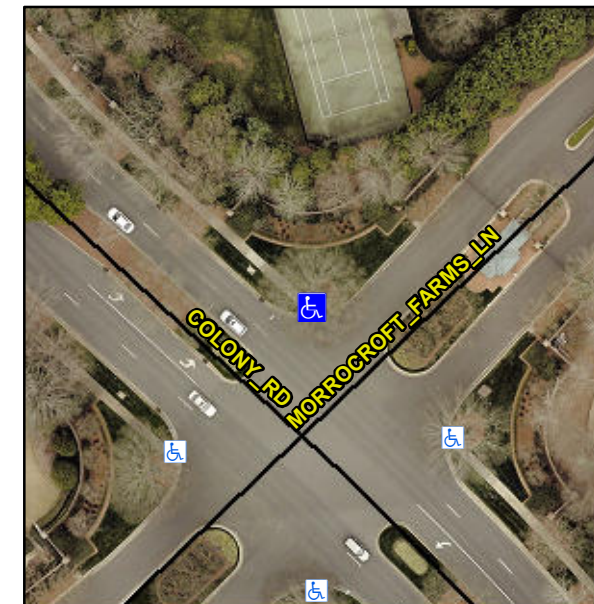
Compliance	Description	Data	Compliance	Description	Data
N/A	Ramp Length (in)	59.0	N/A	Grade Break?	N/A
Yes	Ramp Width (in)	59.0	N/A	Grade Break Slope (%)	0.0
No	Ramp Slope (%)	9.9	N/A	Grade Break XSlope (%)	0.0
No	Ramp XSlope (%)	2.3			
N/A	Flare Type LT	N/A	N/A	Flare Type RT	N/A
N/A	Flare Slope LT (%)	N/A	N/A	Flare Slope RT (%)	0.0
N/A	Flare Traversable LT?	N/A	N/A	Flare Traversable RT?	N/A
N/A	Landing Length (in)	0.0	N/A	DWS Provided?	N/A
N/A	Landing Width (in)	0.0	N/A	DWS Contrast?	N/A
N/A	Landing Slope (%)	0.0	N/A	DWS Length (in)	N/A
N/A	Landing X Slope (%)	0.0	N/A	DWS Full Width?	N/A
N/A	Landing Curb? (Y/N)	N/A	N/A	DWS Offset LT (in)	N/A
N/A	Shared Landing?	N/A	N/A	DWS Offset RT (in)	N/A
N/A	Gutter Ponding?	0.0	N/A	Gutter Slope (%)	N/A
N/A	Gutter Lip Ht (in)	0.0	N/A	Gutter X Slope (%)	N/A
N/A	Painted X Walk1?	No		Road Slope (%)	0.5
	X Walk 1 Direction	To SE		Road X Slope (%)	5.2
	X Walk 1 Width (in)	N/A		Clear Space?	N/A

X Walk 1 Slope (%)	0.5	N/A	Clear Space to XWalk (in)	N/A
	X Walk 1 X Slope (%)	5.2	N/A	Storm Grate/Utility Hazard?	N/A
N/A	Ramp inside XWalk1?	N/A		Storm Grate/Utility Type	
N/A	Any Obstructions?	N/A			N/A
	Obstruction Type		Yes	Surface Condition? (G/P)	Good
			N/A	Curb Slope (%)	7.2

Possible Solutions:

Remove & Replace Entire Ramp.
