# Access Compliance Report

## Public Rights-of-Way

### (Curb Ramps)

| Intersection ID: 28845 | Main Street: FAIRGLEN_RD | Cross Street: FAIRSTONE_AV | Location: NW |

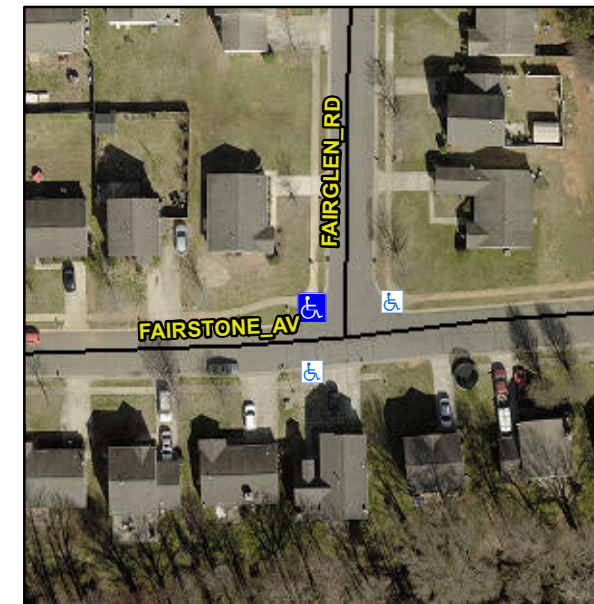
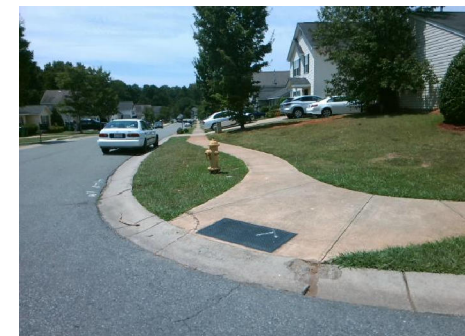
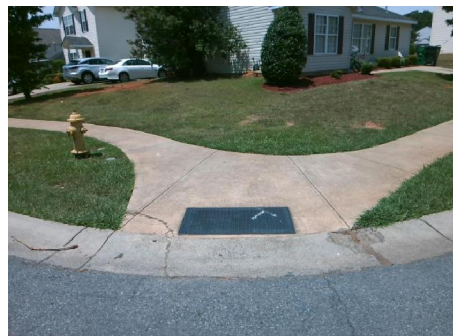
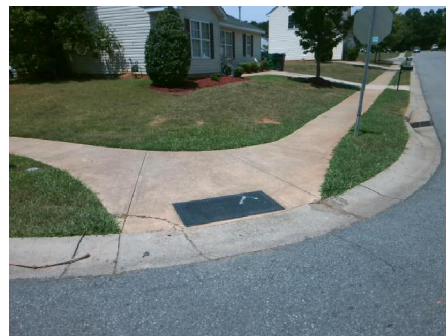
**CRACK LT FL**

**Not Found, R305.1.4, R305.2**

| Compliance | Description | Data | Compliance | Description | Data |
|---|---|---|---|---|---|
| Yes | Landing X Slope (%) | 0.3 | No | DWS Full Width? | No |
| N/A | Landing Curb? (Y/N) | No | No | DWS Offset (in) | 3.0 |

**Remove & Replace Curb Ramp With Two New Directional Ramps or Equivalent.**
