# Access Compliance Report

## Public Rights-of-Way

### (Curb Ramps)

Intersection ID: 13151	Main Street: MERRIMAN_AV	Cross Street: SPRUCE_ST	Location: NW
ADA ID: C8B16E548AF0	Ramp Type: BlendTrans2	Initial Pass/Fail: Fail	Overall Compliance: No
		Severity Score: 10

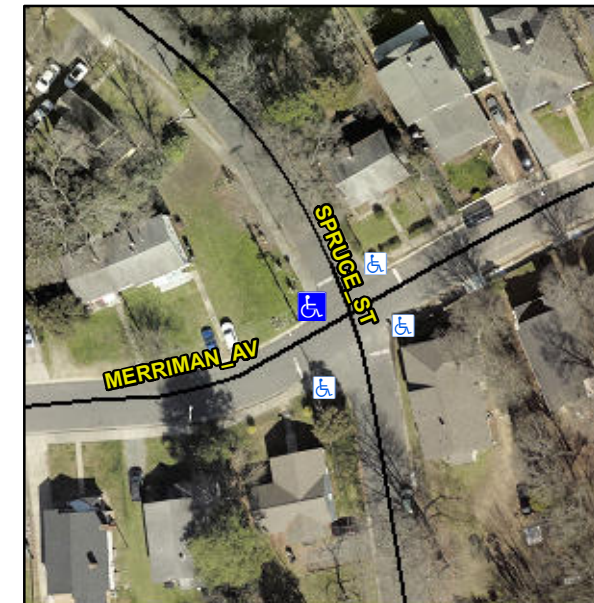
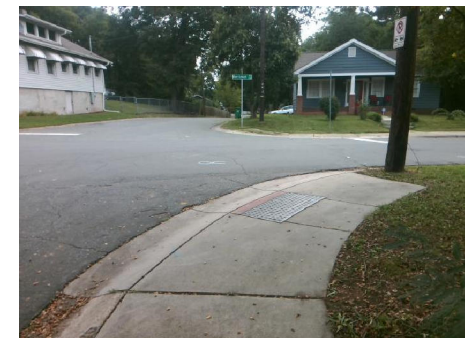
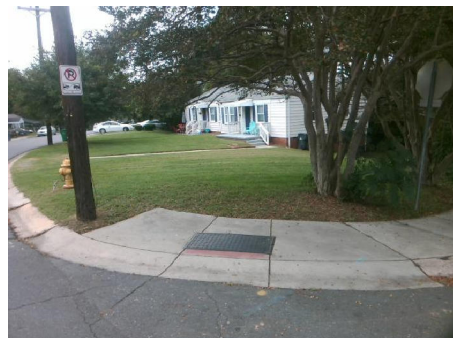
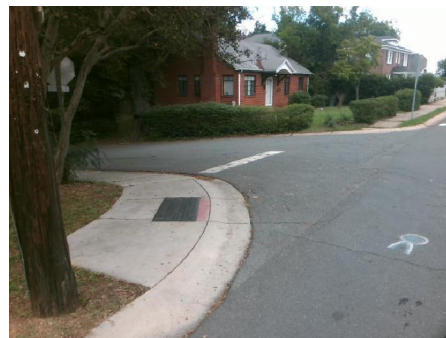
**Not Found, R304.5.1, R304.5.3**

Compliance	Description	Data	Compliance	Description	Data
N/A	Ramp Length (in)	60.0	Yes	BlendTrans Slope (%)	2.1
No	Ramp Width (in)	37.0	No	BlendTrans XSlope (%)	4.2
N/A	Flare Type LT	N/A	N/A	Flare Type RT	N/A
N/A	Flare Slope LT (%)	N/A	N/A	Flare Slope RT (%)	N/A
N/A	Flare Traversable LT?	N/A	N/A	Flare Traversable RT?	N/A
N/A	Landing Length (in)	N/A	N/A	DWS Provided?	N/A
N/A	Landing Width (in)	N/A	N/A	DWS Contrast?	N/A
N/A	Landing Slope (%)	N/A	N/A	DWS Length (in)	N/A
N/A	Landing X Slope (%)	N/A	N/A	DWS Full Width?	N/A
N/A	Landing Curb? (Y/N)	N/A	N/A	DWS Offset (in)	N/A
N/A	Shared Landing?	N/A			
N/A	Gutter Ponding?	N/A	N/A	Gutter Slope (%)	N/A
N/A	Gutter Lip Ht (in)	N/A	N/A	Gutter X Slope (%)	N/A
N/A	Painted X Walk1?	No	N/A	Painted X Walk2?	No
	X Walk 1 Direction	To SE		X Walk 2 Direction	To NE
	X Walk 1 Width (in)	N/A		X Walk 2 Width (in)	N/A
	X Walk 1 Slope (%)	3.0		X Walk 2 Slope (%)	0.6
	X Walk 1 X Slope (%)	2.0		X Walk 2 X Slope (%)	9.1

N/A	Ramp inside XWalk1?	N/A	N/A	Ramp inside XWalk2?	N/A
	Road Slope (%)	0.6		Clear Space?	N/A
	Road X Slope (%)	5.0	N/A	Clear Space to XWalk (in)	N/A
N/A	Any Obstructions?	N/A	N/A	Storm Grate/Utility Hazard?	N/A
	Obstruction Type			Storm Grate/Utility Type	
		N/A			N/A
			Yes	Surface Condition? (G/P)	Good
			No	Curb Slope (%)	17.2

**Remove & Replace Curb Ramp With Two New Directional Ramps or Equivalent.**
