Access Compliance Report

Public Rights-of-Way

(Curb Ramps)

Intersection ID: 5738	Main Street: HIPP_RD	Cross Street: PLEASANT_GROVE_RD	Location:	S
ADA ID: C8B47280FCC2	Ramp Type: Perp	Initial Pass/Fail: Fail	Overall Compliance: No	Severity Score: 10
Codes/Mitigation Info/Possible Solution		Field Measurements/Component Compliance

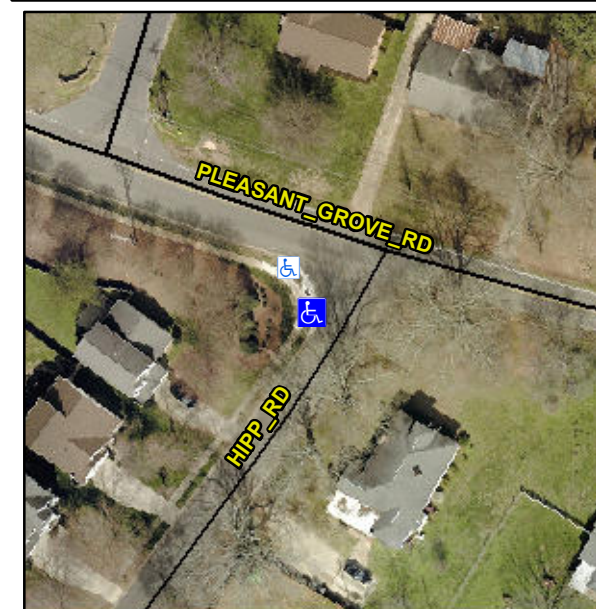
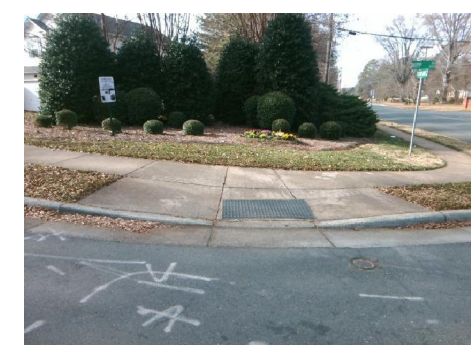
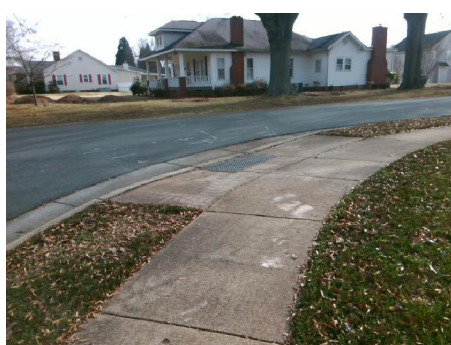
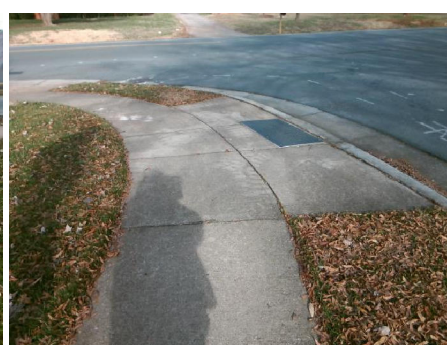
Compliance	Description	Data	Compliance	Description	Data
N/A	Ramp Length (in)	48.0	Yes	Ramp Slope (%)	5.4
No	Ramp Width (in)	40.0	No	Ramp XSlope (%)	2.2
N/A	Flare Type LT	N/A	N/A	Flare Type RT	N/A
N/A	Flare Slope LT (%)	N/A	N/A	Flare Slope RT (%)	N/A
N/A	Flare Traversable LT?	N/A	N/A	Flare Traversable RT?	N/A
N/A	Landing Length (in)	N/A	N/A	DWS Provided?	N/A
N/A	Landing Width (in)	N/A	N/A	DWS Contrast?	N/A
N/A	Landing Slope (%)	N/A	N/A	DWS Length (in)	N/A
N/A	Landing X Slope (%)	N/A	N/A	DWS Full Width?	N/A
N/A	Landing Curb? (Y/N)	N/A	N/A	DWS Offset (in)	N/A
N/A	Shared Landing?	N/A			
N/A	Gutter Ponding?	N/A	N/A	Gutter Slope (%)	N/A
N/A	Gutter Lip Ht (in)	N/A	N/A	Gutter X Slope (%)	N/A
N/A	Painted X Walk1?	No	N/A	Painted X Walk2?	N/A
	X Walk 1 Direction	To E		X Walk 2 Direction	N/A
N/A	X Walk 1 Width (in)	N/A	N/A	X Walk 2 Width (in)	N/A
	X Walk 1 Slope (%)	0.8		X Walk 2 Slope (%)	N/A
	X Walk 1 X Slope (%)	3.3		X Walk 2 X Slope (%)	N/A

N/A	Ramp inside XWalk1?	N/A	N/A	Ramp inside XWalk2?	N/A
	Road Slope (%)	3.3	N/A	Clear Space?	N/A
	Road X Slope (%)	0.8	N/A	Clear Space to XWalk (in)	N/A
N/A	Any Obstructions?	N/A	N/A	Storm Grate/Utility Hazard?	N/A
	Obstruction Type			Storm Grate/Utility Type	
		N/A			N/A
			Yes	Surface Condition? (G/P)	Good

Possible Solutions:

Remove & Replace Entire Ramp.
