Access Compliance Report

Public Rights-of-Way

(Curb Ramps)

Intersection ID: 12958	Main Street: E_3RD_ST	Cross Street: S_DAVIDSON_ST	Location: N
ADA ID: C8B8A2D519BF	Ramp Type: PerpDiag	Initial Pass/Fail: Pass	Overall Compliance: No
Severity Score: 0.25			
Codes/Mitigation Info/Possible Solution		Field Measurements/Component Compliance

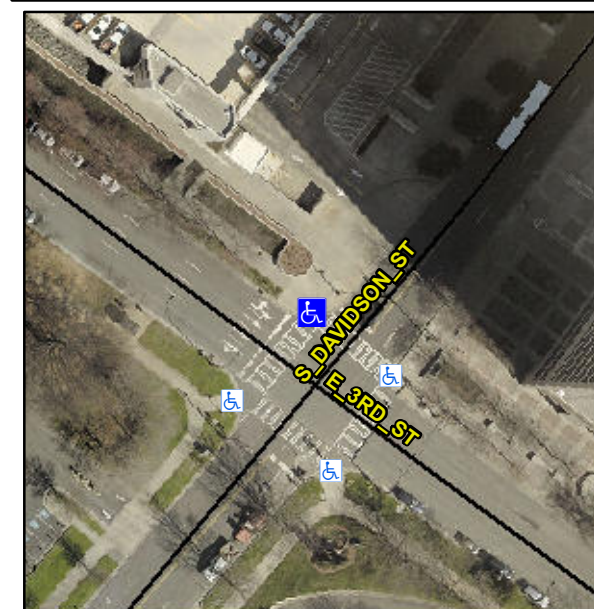
PROW/ADA:

Not Found, R305.2

Compliance	Description	Data	Compliance	Description	Data
N/A	Ramp Length (in)	72.0	Yes	Ramp Slope (%)	4.9
Yes	Ramp Width (in)	48.0	Yes	Ramp XSlope (%)	3.2
N/A	Flare Type LT	Sloped	N/A	Flare Type RT	N/A
N/A	Flare Slope LT (%)	8.2	Yes	Flare Slope RT (%)	3.2
N/A	Flare Traversable LT?	Yes	N/A	Flare Traversable RT?	Yes
Yes	Landing Length (in)	48.0	Yes	DWS Provided?	Yes
Yes	Landing Width (in)	48.0	Yes	DWS Contrast?	Yes
Yes	Landing Slope (%)	1.7	Yes	DWS Length (in)	24.0
Yes	Landing X Slope (%)	3.2	Yes	DWS Full Width?	Yes
N/A	Landing Curb? (Y/N)	No	No	DWS Offset (in)	5.0
N/A	Shared Landing?	No			
Yes	Gutter Ponding?	No	Yes	Gutter Slope (%)	1.2
Yes	Gutter Lip Ht (in)	0.0	Yes	Gutter X Slope (%)	1.9
N/A	Painted X Walk1?	Yes	N/A	Painted X Walk2?	Yes
	X Walk 1 Direction	To SW		X Walk 2 Direction	To SE
N/A	X Walk 1 Width (in)	118.0	N/A	X Walk 2 Width (in)	110.0
	X Walk 1 Slope (%)	3.6		X Walk 2 Slope (%)	0.9
	X Walk 1 X Slope (%)	0.3		X Walk 2 X Slope (%)	3.6

Yes	Ramp inside XWalk1?	Yes	Yes	Ramp inside XWalk2?	Yes
	Road Slope (%)	4.4	N/A	Clear Space?	Yes
	Road X Slope (%)	2.6	Yes	Clear Space to XWalk (in)	68.0
Yes	Any Obstructions?	No	Yes	Storm Grate/Utility Hazard?	No
	Obstruction Type			Storm Grate/Utility Type	
		N/A			N/A
		Yes		Surface Condition? (G/P)	Good

Possible Solutions:

Remove & Replace Curb Ramp With Two New Directional Ramps or Equivalent.
