# Access Compliance Report

## Public Rights-of-Way

### (Curb Ramps)

| Intersection ID: 15373 | Main Street: WINFIELD_DR | Cross Street: PIERSON_DR | Location: | N |

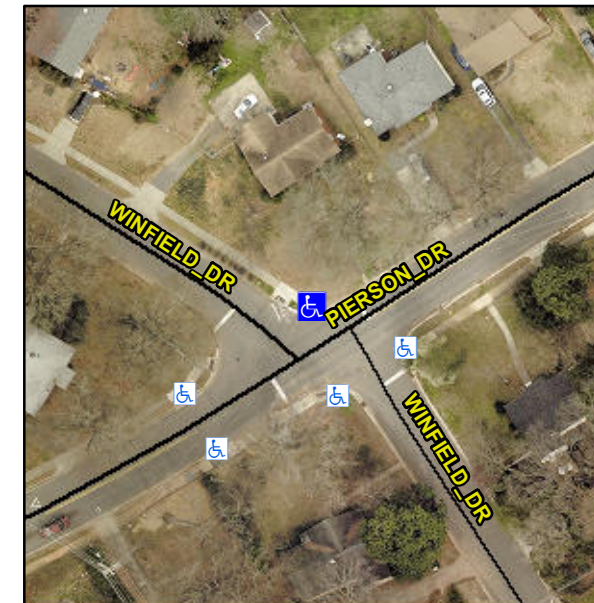
| ADA ID: C8CB5B21FB3F | Ramp Type: BlendTrans1 | Initial Pass/Fail: Fail | Overall Compliance: No | Severity Score: 10 |

**Not Found, R304.5.1, R304.5.3**

| Compliance | Description | Data | Compliance | Description | Data |
|---|---|---|---|---|---|
| No | Ramp Width (in) | 41.0 | No | BlendTrans XSlope (%) | 3.6 |

**Remove & Replace Curb Ramp With Two New Directional Ramps or Equivalent.**
