Access Compliance Report Public Rights-of-Way (Curb Ramps)

Intersection ID: 44919 Main Street: PALUSTRIS CT **Cross Street: MINTVALE_DR** Location: NW **Overall Compliance: No** ADA ID: C8D3C5C98CB6 Ramp Type: Perp Initial Pass/Fail: Fail Severity Score: 26.25

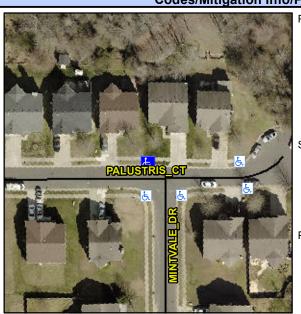
46.0 No

48.0 No

Ramp Slope (%)

Ramp XSlope (%)

i ossible solution		i ieiu ivie
Possible Solutions:	Compl	liance Description
Remove & Replace Entire Ramp.	N/A	Ramp Length (in)
·	Yes	Ramp Width (in)
	N/A	Flare Type LT
	N/A	Flare Slope LT (%)
	N/A	Flare Traversable LT
	N/A	Landing Length (in)
Surveyor Notes:	N/A	Landing Width (in)
N/A	N/A	Landing Slope (%)
	N/A	Landing X Slope (%)
	N/A	Landing Curb? (Y/N)
	N/A	Shared Landing?
PROW/ADA:	N/A	Gutter Ponding?
Not Found, R304.2.2, R304.5.3	N/A	Gutter Lip Ht (in)
	N/A	Painted X Walk1?
		X Walk 1 Direction
	N/A	X Walk 1 Width (in)
		X Walk 1 Slope (%)
		X Walk 1 X Slope (%
	N/A	Ramp inside XWalk1
		Road Slope (%)
