# Access Compliance Report

## Public Rights-of-Way

### (Curb Ramps)

Intersection ID: 10035583	Main Street: REAMES_RD	Cross Street: N/A	Location: E
ADA ID: C8E26F021B67	Ramp Type: Perp	Initial Pass/Fail: Fail	Overall Compliance: No
Severity Score: 12.5			
Codes/Mitigation Info/Possible Solution		Field Measurements/Component Compliance

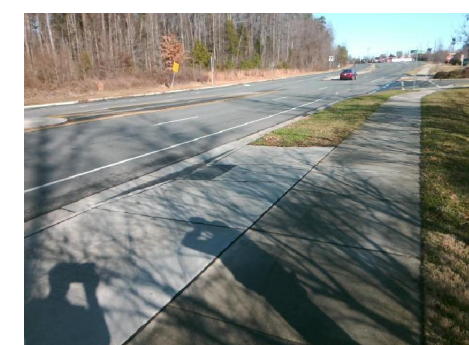
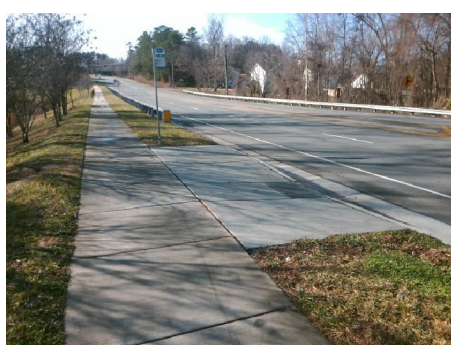
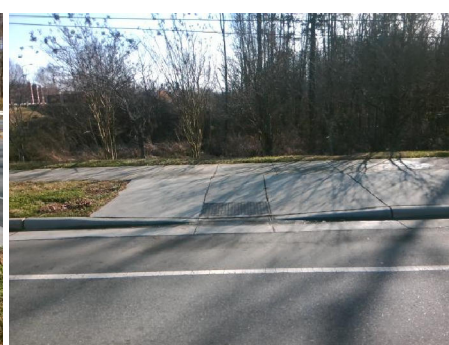
Compliance	Description	Data	Compliance	Description	Data
N/A	Ramp Length (in)	95.0	No	Ramp Slope (%)	10.3
Yes	Ramp Width (in)	48.0	Yes	Ramp XSlope (%)	0.7
N/A	Flare Type LT	N/A	N/A	Flare Type RT	N/A
N/A	Flare Slope LT (%)	N/A	N/A	Flare Slope RT (%)	N/A
N/A	Flare Traversable LT?	N/A	N/A	Flare Traversable RT?	N/A
N/A	Landing Length (in)	N/A	N/A	DWS Provided?	N/A
N/A	Landing Width (in)	N/A	N/A	DWS Contrast?	N/A
N/A	Landing Slope (%)	N/A	N/A	DWS Length (in)	N/A
N/A	Landing X Slope (%)	N/A	N/A	DWS Full Width?	N/A
N/A	Landing Curb? (Y/N)	N/A	N/A	DWS Offset (in)	N/A
N/A	Shared Landing?	N/A			
N/A	Gutter Ponding?	N/A	N/A	Gutter Slope (%)	N/A
N/A	Gutter Lip Ht (in)	N/A	N/A	Gutter X Slope (%)	N/A
N/A	Painted X Walk1?	No	N/A	Painted X Walk2?	N/A
	X Walk 1 Direction	To NW		X Walk 2 Direction	N/A
N/A	X Walk 1 Width (in)	N/A	N/A	X Walk 2 Width (in)	N/A
	X Walk 1 Slope (%)	0.1		X Walk 2 Slope (%)	N/A
	X Walk 1 X Slope (%)	0.7		X Walk 2 X Slope (%)	N/A

N/A	Ramp inside XWalk1?	N/A	N/A	Ramp inside XWalk2?	N/A
	Road Slope (%)	N/A	N/A	Clear Space?	N/A
	Road X Slope (%)	N/A	N/A	Clear Space to XWalk (in)	N/A
N/A	Any Obstructions?	N/A	N/A	Storm Grate/Utility Hazard?	N/A
	Obstruction Type			Storm Grate/Utility Type	
		N/A			N/A
			Yes	Surface Condition? (G/P)	Good

**Remove & Replace Entire Ramp.**

**Not Found, R304.2.2**
