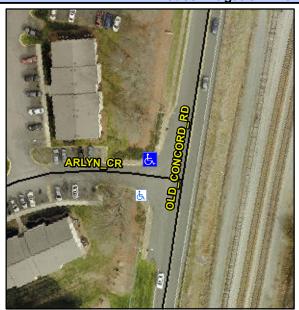
Intersection ID: N/AMain Street:ARLYN_CRCross Street:OLD_CONCORD_RDLocation:NWADA ID: C8E8A2924889Ramp Type:PerpDiagInitial Pass/Fail:FailOverall Compliance:NoSeverity Score:13.75

Field Measurements/Component Compliance						
	Compliance Description		Data	Comp	liance Description	Data
	N/A	Ramp Length (in)	47.0	No	Ramp Slope (%)	11.2
	Yes	Ramp Width (in)	60.0	No	Ramp XSlope (%)	2.8
	N/A	Flare Type LT	N/A	N/A	Flare Type RT	N/A
	N/A	Flare Slope LT (%)	N/A	N/A	Flare Slope RT (%)	N/A
	N/A	Flare Traversable LT?	N/A	N/A	Flare Traversable RT?	N/A
	N/A	Landing Length (in)	N/A	N/A	DWS Provided?	N/A
	N/A	Landing Width (in)	N/A	N/A	DWS Contrast?	N/A
	N/A	Landing Slope (%)	N/A	N/A	DWS Length (in)	N/A
	N/A	Landing X Slope (%)	N/A	N/A	DWS Full Width?	N/A
	N/A	Landing Curb? (Y/N)	N/A	N/A	DWS Offset (in)	N/A
	N/A	Shared Landing?	N/A			
	N/A	Gutter Ponding?	N/A	N/A	Gutter Slope (%)	N/A
	N/A	Gutter Lip Ht (in)	N/A	N/A	Gutter X Slope (%)	N/A
	N/A	Painted X Walk1?	No	N/A	Painted X Walk2?	No
		X Walk 1 Direction	To S		X Walk 2 Direction	То Е
	N/A	X Walk 1 Width (in)	N/A	N/A	X Walk 2 Width (in)	N/A
		X Walk 1 Slope (%)	3.3		X Walk 2 Slope (%)	0.6

X Walk 1 X Slope (%)	0.4		X Walk 2 X Slope (%)	2.6
	N/A	Ramp inside XWalk1?	N/A	N/A	Ramp inside XWalk2?	N/A
		Road Slope (%)	1.1	N/A	Clear Space?	N/A
		Road X Slope (%)	0.5	N/A	Clear Space to XWalk (in)	N/A
	N/A	Any Obstructions?	N/A	N/A	Storm Grate/Utility Hazard?	N/A
		Obstruction Type			Storm Grate/Utility Type	
			N/A			N/A
				Yes	Surface Condition? (G/P)	Good
_

Remove & Replace Curb Ramp With Two New Directional Ramps or Equivalent.

PROW/ADA:
R304.2.2, R304.5.3
