Access Compliance Report

Public Rights-of-Way

(Curb Ramps)

Intersection ID: 18781	Main Street: LACIE_LN	Cross Street: RUNNYMEDE_LN	Location: NW
ADA ID: C8F07C661AA5	Ramp Type: PerpDiag	Initial Pass/Fail: Fail	Overall Compliance: No
Codes/Mitigation Info/Possible Solution			Severity Score: 50
			Field Measurements/Component Compliance

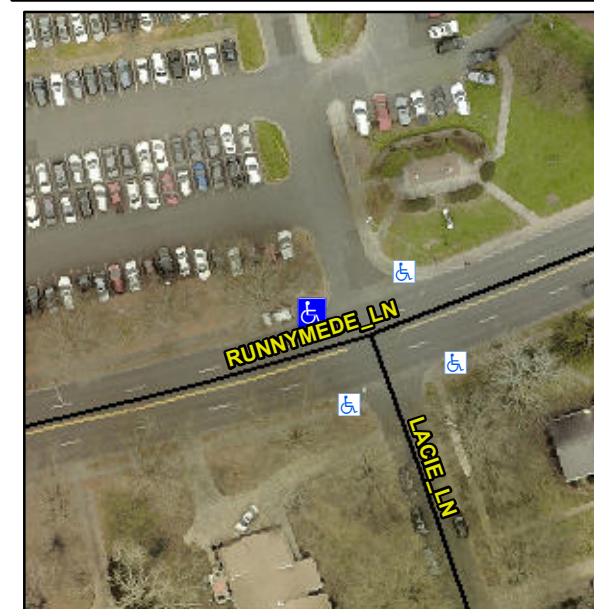
Not Found, R304.2.2, R304.5.3

Compliance	Description	Data	Compliance	Description	Data
N/A	Ramp Length (in)	64.0	No	Ramp Slope (%)	15.6
Yes	Ramp Width (in)	48.0	No	Ramp XSlope (%)	11.5
N/A	Flare Type LT	N/A	N/A	Flare Type RT	N/A
N/A	Flare Slope LT (%)	N/A	N/A	Flare Slope RT (%)	N/A
N/A	Flare Traversable LT?	N/A	N/A	Flare Traversable RT?	N/A
N/A	Landing Length (in)	N/A	N/A	DWS Provided?	N/A
N/A	Landing Width (in)	N/A	N/A	DWS Contrast?	N/A
N/A	Landing Slope (%)	N/A	N/A	DWS Length (in)	N/A
N/A	Landing X Slope (%)	N/A	N/A	DWS Full Width?	N/A
N/A	Landing Curb? (Y/N)	N/A	N/A	DWS Offset (in)	N/A
N/A	Shared Landing?	N/A			
N/A	Gutter Ponding?	N/A	N/A	Gutter Slope (%)	N/A
N/A	Gutter Lip Ht (in)	N/A	N/A	Gutter X Slope (%)	N/A
N/A	Painted X Walk1?	No	N/A	Painted X Walk2?	No
	X Walk 1 Direction	To S		X Walk 2 Direction	To E
N/A	X Walk 1 Width (in)	N/A	N/A	X Walk 2 Width (in)	N/A
	X Walk 1 Slope (%)	1.7		X Walk 2 Slope (%)	2.9
	X Walk 1 X Slope (%)	3.0		X Walk 2 X Slope (%)	0.6

Possible Solutions:

Remove & Replace Curb Ramp With Two New Directional Ramps or Equivalent.
