Access Compliance Report

Public Rights-of-Way

(Curb Ramps)

Intersection ID: 3626	Main Street: LEXINGTON_APPROACH_DR	Cross Street: MALLARD_CREEK_RD	Location:	S
ADA ID: C8FF9D795A10	Ramp Type: Perp	Initial Pass/Fail: Fail	Overall Compliance: No	Severity Score: 25
Codes/Mitigation Info/Possible Solution		Field Measurements/Component Compliance

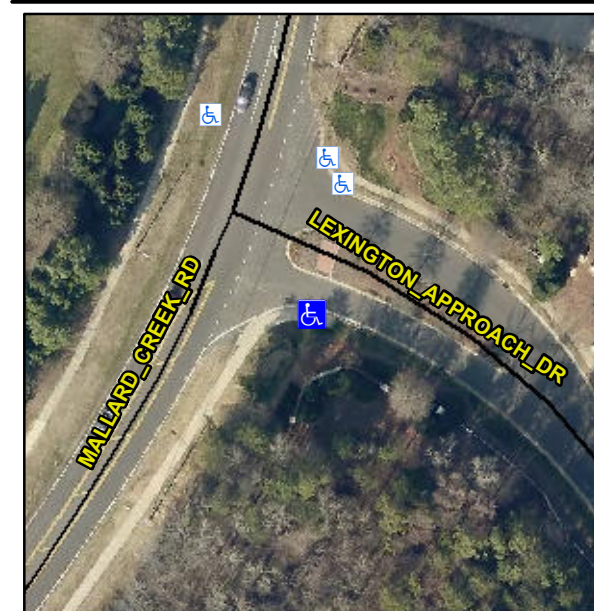
R304.2.2

Compliance	Description	Data	Compliance	Description	Data
N/A	Ramp Length (in)	72.0	No	Ramp Slope (%)	20.0
Yes	Ramp Width (in)	48.0	Yes	Ramp XSlope (%)	1.4
N/A	Flare Type LT	N/A	N/A	Flare Type RT	N/A
N/A	Flare Slope LT (%)	N/A	N/A	Flare Slope RT (%)	N/A
N/A	Flare Traversable LT?	N/A	N/A	Flare Traversable RT?	N/A
N/A	Landing Length (in)	N/A	N/A	DWS Provided?	N/A
N/A	Landing Width (in)	N/A	N/A	DWS Contrast?	N/A
N/A	Landing Slope (%)	N/A	N/A	DWS Length (in)	N/A
N/A	Landing X Slope (%)	N/A	N/A	DWS Full Width?	N/A
N/A	Landing Curb? (Y/N)	N/A	N/A	DWS Offset (in)	N/A
N/A	Shared Landing?	N/A			
N/A	Gutter Ponding?	N/A	N/A	Gutter Slope (%)	N/A
N/A	Gutter Lip Ht (in)	N/A	N/A	Gutter X Slope (%)	N/A
N/A	Painted X Walk1?	No	N/A	Painted X Walk2?	N/A
	X Walk 1 Direction	To NE		X Walk 2 Direction	N/A
N/A	X Walk 1 Width (in)	N/A	N/A	X Walk 2 Width (in)	N/A
	X Walk 1 Slope (%)	3.6		X Walk 2 Slope (%)	N/A
	X Walk 1 X Slope (%)	3.3		X Walk 2 X Slope (%)	N/A

N/A	Ramp inside XWalk1?	N/A	N/A	Ramp inside XWalk2?	N/A
	Road Slope (%)	N/A	N/A	Clear Space?	N/A
	Road X Slope (%)	N/A	N/A	Clear Space to XWalk (in)	N/A
N/A	Any Obstructions?	N/A	N/A	Storm Grate/Utility Hazard?	N/A
	Obstruction Type			Storm Grate/Utility Type	
		N/A			N/A
			Yes	Surface Condition? (G/P)	Good

Possible Solutions:

Remove & Replace Entire Ramp.

\$ 1850.00
