Access Compliance Report

Public Rights-of-Way

(Curb Ramps)

Intersection ID: N/A	Main Street: ROUNDING_RUN_LN	Cross Street: RISING_MEADOW_RD	Location: NE
ADA ID: C903A815EFF9	Ramp Type: PerpDiag	Initial Pass/Fail: Fail	Overall Compliance: No
		Severity Score: 12.5

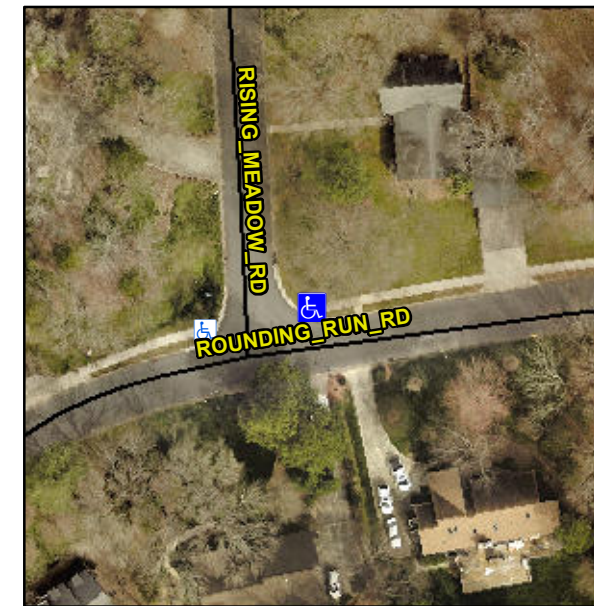
Not Found, R304.5.3

Compliance	Description	Data	Compliance	Description	Data
N/A	Ramp Length (in)	39.0	Yes	Ramp Slope (%)	5.0
Yes	Ramp Width (in)	60.0	No	Ramp XSlope (%)	5.4
N/A	Flare Type LT	N/A	N/A	Flare Type RT	N/A
N/A	Flare Slope LT (%)	N/A	N/A	Flare Slope RT (%)	N/A
N/A	Flare Traversable LT?	N/A	N/A	Flare Traversable RT?	N/A
N/A	Landing Length (in)	N/A	N/A	DWS Provided?	N/A
N/A	Landing Width (in)	N/A	N/A	DWS Contrast?	N/A
N/A	Landing Slope (%)	N/A	N/A	DWS Length (in)	N/A
N/A	Landing X Slope (%)	N/A	N/A	DWS Full Width?	N/A
N/A	Landing Curb? (Y/N)	N/A	N/A	DWS Offset (in)	N/A
N/A	Shared Landing?	N/A			
N/A	Gutter Ponding?	N/A	N/A	Gutter Slope (%)	N/A
N/A	Gutter Lip Ht (in)	N/A	N/A	Gutter X Slope (%)	N/A
N/A	Painted X Walk1?	No	N/A	Painted X Walk2?	No
	X Walk 1 Direction	To W		X Walk 2 Direction	To S
N/A	X Walk 1 Width (in)	N/A	N/A	X Walk 2 Width (in)	N/A
	X Walk 1 Slope (%)	4.7		X Walk 2 Slope (%)	0.2
	X Walk 1 X Slope (%)	1.4		X Walk 2 X Slope (%)	4.0

N/A	Ramp inside XWalk1?	N/A	N/A	Ramp inside XWalk2?	N/A
	Road Slope (%)	1.9	N/A	Clear Space?	N/A
	Road X Slope (%)	6.5	N/A	Clear Space to XWalk (in)	N/A
N/A	Any Obstructions?	N/A	N/A	Storm Grate/Utility Hazard?	N/A
	Obstruction Type			Storm Grate/Utility Type	
		N/A			N/A
			Yes	Surface Condition? (G/P)	Good

Remove & Replace Curb Ramp With Two New Directional Ramps or Equivalent.
