Access Compliance Report

Public Rights-of-Way

(Curb Ramps)

Intersection ID: 44850	Main Street: STEELE_CREEK_RD	Cross Street: SHOPTON_RD_WEST	Location: SW
ADA ID: C905AAE0CA81	Ramp Type: BlendTrans1	Initial Pass/Fail: Fail	Overall Compliance: No
Severity Score: 10			
Codes/Mitigation Info/Possible Solution		Field Measurements/Component Compliance

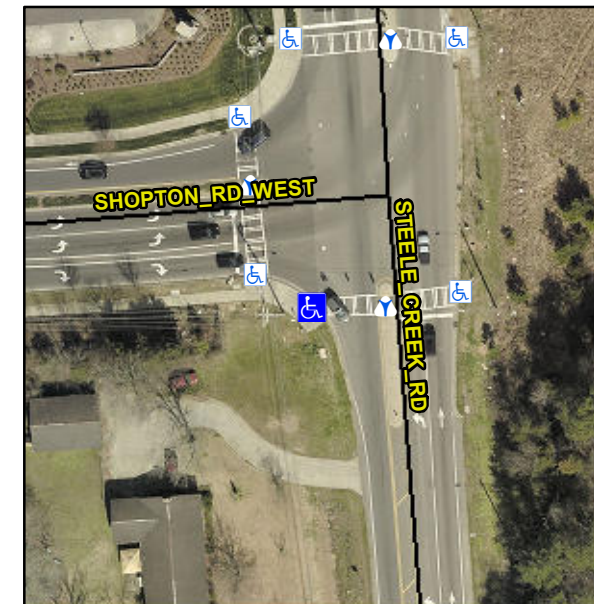
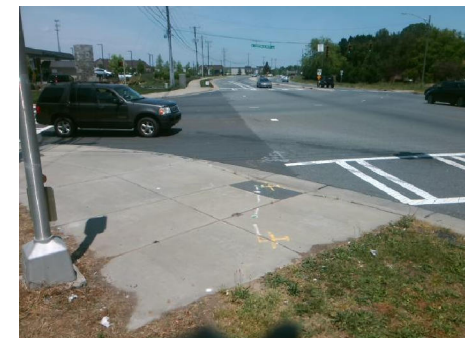
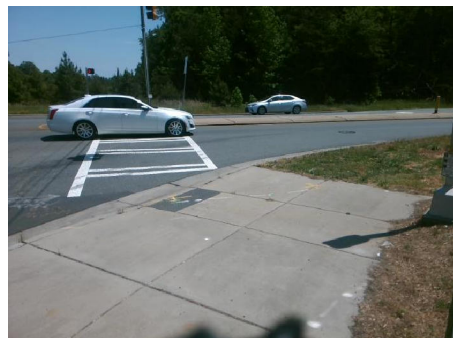
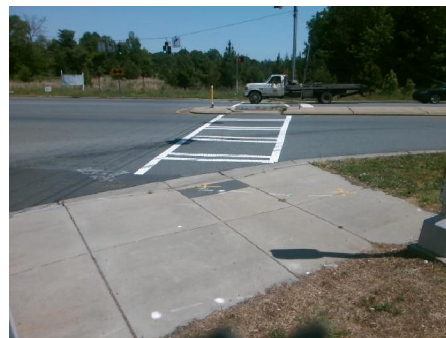
Not Found, R304.5.1, R304.5.3

Compliance	Description	Data	Compliance	Description	Data
N/A	Ramp Length (in)	72.0	Yes	BlendTrans Slope (%)	3.8
No	Ramp Width (in)	47.0	No	BlendTrans XSlope (%)	2.1
N/A	Flare Type LT	N/A	N/A	Flare Type RT	N/A
N/A	Flare Slope LT (%)	N/A	N/A	Flare Slope RT (%)	N/A
N/A	Flare Traversable LT?	N/A	N/A	Flare Traversable RT?	N/A
N/A	Landing Length (in)	N/A	N/A	DWS Provided?	N/A
N/A	Landing Width (in)	N/A	N/A	DWS Contrast?	N/A
N/A	Landing Slope (%)	N/A	N/A	DWS Length (in)	N/A
N/A	Landing X Slope (%)	N/A	N/A	DWS Full Width?	N/A
N/A	Landing Curb? (Y/N)	N/A	N/A	DWS Offset (in)	N/A
N/A	Shared Landing?	N/A			
N/A	Gutter Ponding?	N/A	N/A	Gutter Slope (%)	N/A
N/A	Gutter Lip Ht (in)	N/A	N/A	Gutter X Slope (%)	N/A
N/A	Painted X Walk1?	Yes	N/A	Painted X Walk2?	N/A
	X Walk 1 Direction	To E		X Walk 2 Direction	N/A
	X Walk 1 Width (in)	99.0		X Walk 2 Width (in)	N/A
	X Walk 1 Slope (%)	7.5		X Walk 2 Slope (%)	N/A
	X Walk 1 X Slope (%)	1.2		X Walk 2 X Slope (%)	N/A

N/A	Ramp inside XWalk1?	Yes	N/A	Ramp inside XWalk2?	N/A
	Road Slope (%)	1.2		Clear Space?	N/A
	Road X Slope (%)	7.5	N/A	Clear Space to XWalk (in)	N/A
N/A	Any Obstructions?	N/A	N/A	Storm Grate/Utility Hazard?	N/A
	Obstruction Type			Storm Grate/Utility Type	
		N/A			N/A
			Yes	Surface Condition? (G/P)	Good
			No	Curb Slope (%)	11.2

Remove & Replace Curb Ramp With Two New Directional Ramps or Equivalent.
