# Access Compliance Report

## Public Rights-of-Way

### (Curb Ramps)

Intersection ID: 10025870	Main Street: ELEVATION_POINT_DR	Cross Street: N/A	Location: NE
ADA ID: C9074276865E	Ramp Type: Perp	Initial Pass/Fail: Fail	Overall Compliance: No
Severity Score: 13.75			
Codes/Mitigation Info/Possible Solution		Field Measurements/Component Compliance

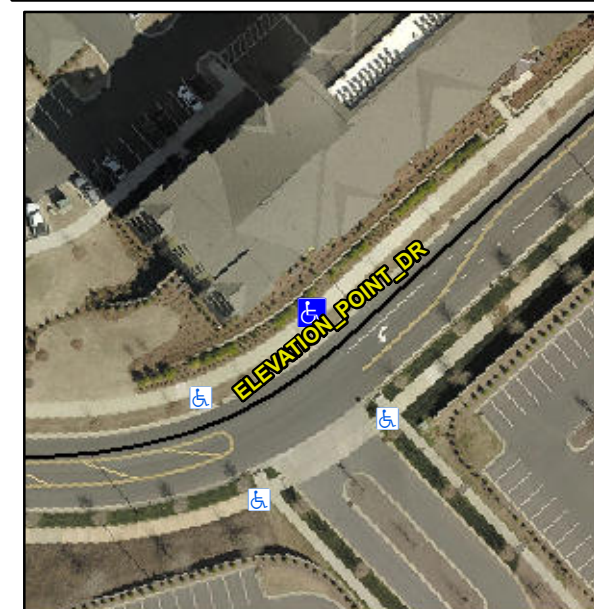
Compliance	Description	Data	Compliance	Description	Data
N/A	Ramp Length (in)	95.0	No	Ramp Slope (%)	8.6
Yes	Ramp Width (in)	58.0	No	Ramp XSlope (%)	2.7
N/A	Flare Type LT	N/A	N/A	Flare Type RT	N/A
N/A	Flare Slope LT (%)	N/A	N/A	Flare Slope RT (%)	N/A
N/A	Flare Traversable LT?	N/A	N/A	Flare Traversable RT?	N/A
N/A	Landing Length (in)	N/A	N/A	DWS Provided?	N/A
N/A	Landing Width (in)	N/A	N/A	DWS Contrast?	N/A
N/A	Landing Slope (%)	N/A	N/A	DWS Length (in)	N/A
N/A	Landing X Slope (%)	N/A	N/A	DWS Full Width?	N/A
N/A	Landing Curb? (Y/N)	N/A	N/A	DWS Offset (in)	N/A
N/A	Shared Landing?	N/A			
N/A	Gutter Ponding?	N/A	N/A	Gutter Slope (%)	N/A
N/A	Gutter Lip Ht (in)	N/A	N/A	Gutter X Slope (%)	N/A
N/A	Painted X Walk1?	No	N/A	Painted X Walk2?	N/A
	X Walk 1 Direction	To SE		X Walk 2 Direction	N/A
N/A	X Walk 1 Width (in)	N/A	N/A	X Walk 2 Width (in)	N/A
	X Walk 1 Slope (%)	3.2		X Walk 2 Slope (%)	N/A
	X Walk 1 X Slope (%)	2.0		X Walk 2 X Slope (%)	N/A

N/A	Ramp inside XWalk1?	N/A	N/A	Ramp inside XWalk2?	N/A
	Road Slope (%)	N/A	N/A	Clear Space?	N/A
	Road X Slope (%)	N/A	N/A	Clear Space to XWalk (in)	N/A
N/A	Any Obstructions?	N/A	N/A	Storm Grate/Utility Hazard?	N/A
	Obstruction Type			Storm Grate/Utility Type	
		N/A			N/A
			Yes	Surface Condition? (G/P)	Good

Possible Solutions:

**Remove & Replace Entire Ramp.**

**R304.2.2, R304.5.3**
