Access Compliance Report

Public Rights-of-Way

(Curb Ramps)

Intersection ID: 13912	Main Street: KENILWORTH_AV	Cross Street: E JOHN BELK_RA	Location: SE
ADA ID: C9076E4F1ED9	Ramp Type: BlendTrans1	Initial Pass/Fail: Fail	Overall Compliance: No
Severity Score: 25			
Codes/Mitigation Info/Possible Solution		Field Measurements/Component Compliance

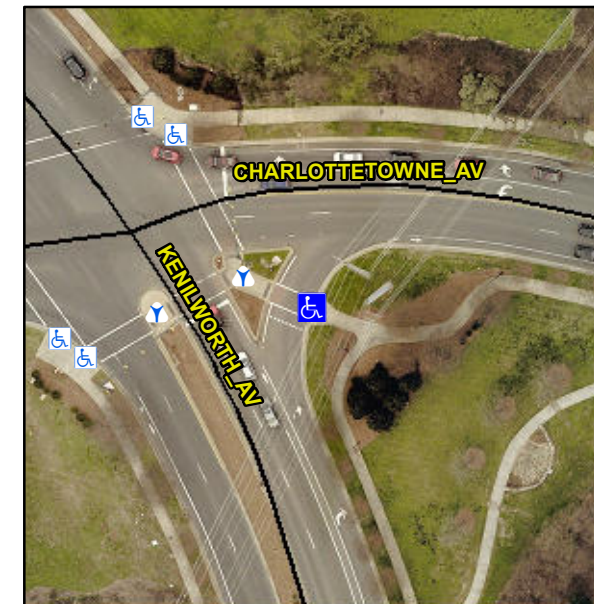
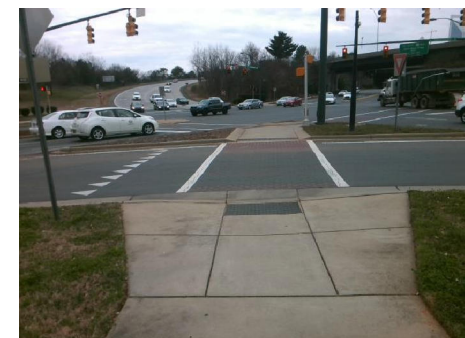
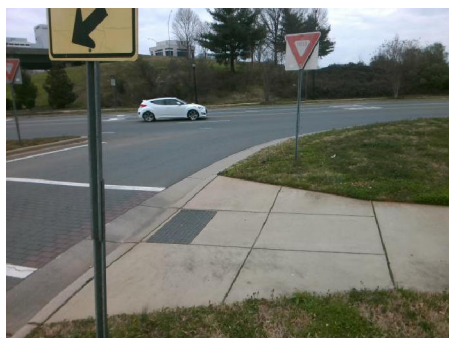
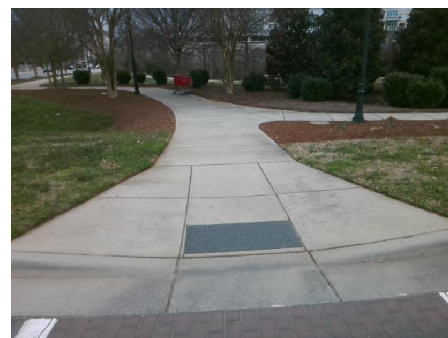
XWALK PAVERS

Compliance	Description	Data	Compliance	Description	Data
N/A	Ramp Length (in)	59.0	Yes	BlendTrans Slope (%)	1.6
Yes	Ramp Width (in)	48.0	No	BlendTrans XSlope (%)	11.5
N/A	Flare Type LT	N/A	N/A	Flare Type RT	N/A
N/A	Flare Slope LT (%)	N/A	N/A	Flare Slope RT (%)	N/A
N/A	Flare Traversable LT?	N/A	N/A	Flare Traversable RT?	N/A
N/A	Landing Length (in)	N/A	N/A	DWS Provided?	N/A
N/A	Landing Width (in)	N/A	N/A	DWS Contrast?	N/A
N/A	Landing Slope (%)	N/A	N/A	DWS Length (in)	N/A
N/A	Landing X Slope (%)	N/A	N/A	DWS Full Width?	N/A
N/A	Landing Curb? (Y/N)	N/A	N/A	DWS Offset (in)	N/A
N/A	Shared Landing?	N/A			
N/A	Gutter Ponding?	N/A	N/A	Gutter Slope (%)	N/A
N/A	Gutter Lip Ht (in)	N/A	N/A	Gutter X Slope (%)	N/A
N/A	Painted X Walk1?	Yes	N/A	Painted X Walk2?	N/A
	X Walk 1 Direction	To NW		X Walk 2 Direction	N/A
	X Walk 1 Width (in)	117.0		X Walk 2 Width (in)	N/A
	X Walk 1 Slope (%)	1.0		X Walk 2 Slope (%)	N/A
	X Walk 1 X Slope (%)	2.1		X Walk 2 X Slope (%)	N/A

N/A	Ramp inside XWalk1?	Yes	N/A	Ramp inside XWalk2?	N/A
	Road Slope (%)	2.1		Clear Space?	N/A
	Road X Slope (%)	1.0	N/A	Clear Space to XWalk (in)	N/A
N/A	Any Obstructions?	N/A	N/A	Storm Grate/Utility Hazard?	N/A
	Obstruction Type			Storm Grate/Utility Type	
		N/A			N/A
			Yes	Surface Condition? (G/P)	Good
			N/A	Curb Slope (%)	3.2

Possible Solutions:

Remove & Replace Curb Ramp With Two New Directional Ramps or Equivalent.

R304.5.3
