# Access Compliance Report

## Public Rights-of-Way

### (Curb Ramps)

Intersection ID: 3740	Main Street: CHESTNUT_KNOLL_LN	Cross Street: DAVIS_LAKE_PY	Location: S
ADA ID: C90F6673ABA5	Ramp Type: Perp	Initial Pass/Fail: Fail	Overall Compliance: No
Severity Score: 8.75			
Codes/Mitigation Info/Possible Solution		Field Measurements/Component Compliance

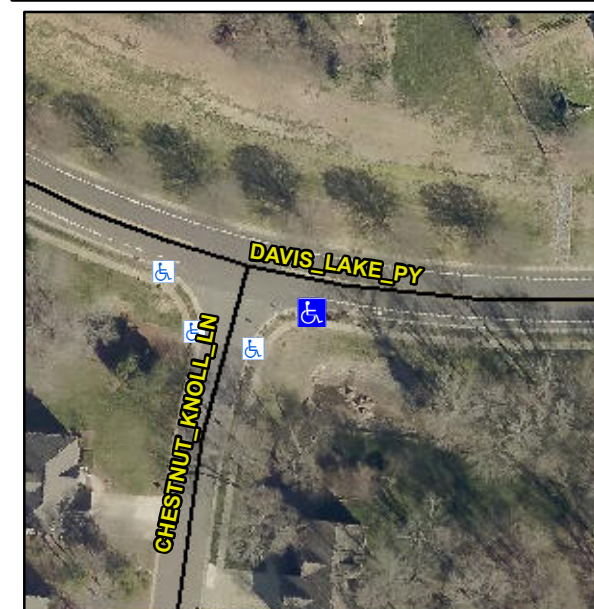
**Not Found, R304.5.1**

Compliance	Description	Data	Compliance	Description	Data
N/A	Ramp Length (in)	52.0	Yes	Ramp Slope (%)	6.9
No	Ramp Width (in)	45.5	Yes	Ramp XSlope (%)	0.8
N/A	Flare Type LT	N/A	N/A	Flare Type RT	N/A
N/A	Flare Slope LT (%)	N/A	N/A	Flare Slope RT (%)	N/A
N/A	Flare Traversable LT?	N/A	N/A	Flare Traversable RT?	N/A
N/A	Landing Length (in)	N/A	N/A	DWS Provided?	N/A
N/A	Landing Width (in)	N/A	N/A	DWS Contrast?	N/A
N/A	Landing Slope (%)	N/A	N/A	DWS Length (in)	N/A
N/A	Landing X Slope (%)	N/A	N/A	DWS Full Width?	N/A
N/A	Landing Curb? (Y/N)	N/A	N/A	DWS Offset (in)	N/A
N/A	Shared Landing?	N/A			
N/A	Gutter Ponding?	N/A	N/A	Gutter Slope (%)	N/A
N/A	Gutter Lip Ht (in)	N/A	N/A	Gutter X Slope (%)	N/A
N/A	Painted X Walk1?	No	N/A	Painted X Walk2?	N/A
	X Walk 1 Direction	To NE		X Walk 2 Direction	N/A
N/A	X Walk 1 Width (in)	N/A	N/A	X Walk 2 Width (in)	N/A
	X Walk 1 Slope (%)	5.0		X Walk 2 Slope (%)	N/A
	X Walk 1 X Slope (%)	1.4		X Walk 2 X Slope (%)	N/A

N/A	Ramp inside XWalk1?	N/A	N/A	Ramp inside XWalk2?	N/A
	Road Slope (%)	N/A	N/A	Clear Space?	N/A
	Road X Slope (%)	N/A	N/A	Clear Space to XWalk (in)	N/A
N/A	Any Obstructions?	N/A	N/A	Storm Grate/Utility Hazard?	N/A
	Obstruction Type			Storm Grate/Utility Type	
		N/A			N/A
			Yes	Surface Condition? (G/P)	Good

Possible Solutions:

**Remove & Replace Entire Ramp.**

Total Cost: \$ 1850.00
