Access Compliance Report

Public Rights-of-Way

(Curb Ramps)

Intersection ID: 26209	Main Street: CARMEL_RD	Cross Street: JOHNSTON_RD	Location: SE
ADA ID: C9101FD63859	Ramp Type: Perp	Initial Pass/Fail: Fail	Overall Compliance: No
Severity Score: 8.75			
Codes/Mitigation Info/Possible Solution		Field Measurements/Component Compliance

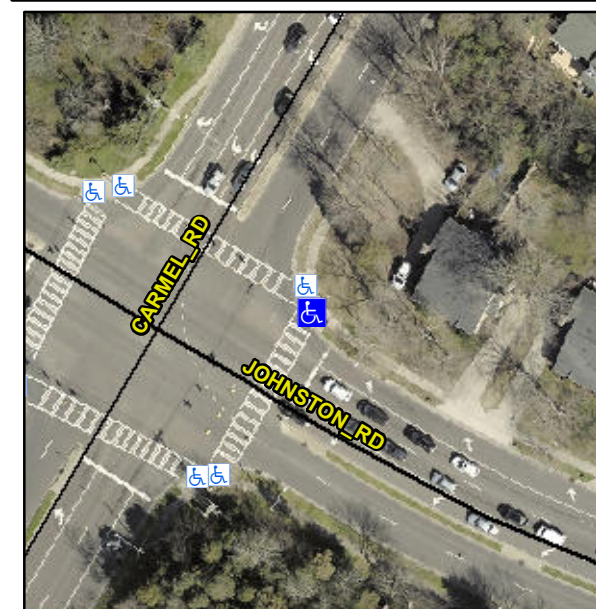
Compliance	Description	Data	Compliance	Description	Data
N/A	Ramp Length (in)	60.0	Yes	Ramp Slope (%)	7.5
No	Ramp Width (in)	45.5	Yes	Ramp XSlope (%)	1.8
N/A	Flare Type LT	N/A	N/A	Flare Type RT	N/A
N/A	Flare Slope LT (%)	N/A	N/A	Flare Slope RT (%)	N/A
N/A	Flare Traversable LT?	N/A	N/A	Flare Traversable RT?	N/A
N/A	Landing Length (in)	N/A	N/A	DWS Provided?	N/A
N/A	Landing Width (in)	N/A	N/A	DWS Contrast?	N/A
N/A	Landing Slope (%)	N/A	N/A	DWS Length (in)	N/A
N/A	Landing X Slope (%)	N/A	N/A	DWS Full Width?	N/A
N/A	Landing Curb? (Y/N)	N/A	N/A	DWS Offset (in)	N/A
N/A	Shared Landing?	N/A			
N/A	Gutter Ponding?	N/A	N/A	Gutter Slope (%)	N/A
N/A	Gutter Lip Ht (in)	N/A	N/A	Gutter X Slope (%)	N/A
N/A	Painted X Walk1?	Yes	N/A	Painted X Walk2?	N/A
	X Walk 1 Direction	To SW		X Walk 2 Direction	N/A
N/A	X Walk 1 Width (in)	135.0	N/A	X Walk 2 Width (in)	N/A
	X Walk 1 Slope (%)	3.1		X Walk 2 Slope (%)	N/A
	X Walk 1 X Slope (%)	3.4		X Walk 2 X Slope (%)	N/A

N/A	Ramp inside XWalk1?	Yes	N/A	Ramp inside XWalk2?	N/A
	Road Slope (%)	N/A	N/A	Clear Space?	N/A
	Road X Slope (%)	N/A	N/A	Clear Space to XWalk (in)	N/A
N/A	Any Obstructions?	N/A	N/A	Storm Grate/Utility Hazard?	N/A
	Obstruction Type			Storm Grate/Utility Type	
		N/A			N/A
		Yes		Surface Condition? (G/P)	Good

Possible Solutions:

Remove & Replace Entire Ramp.

R304.5.1
