Access Compliance Report

Public Rights-of-Way

(Curb Ramps)

Intersection ID: 42769	Main Street: ERWIN_RIDGE_AV	Cross Street: JEANETTE_CR	Location: W
ADA ID: C915A8DA8AB6	Ramp Type: PerpDiag	Initial Pass/Fail: Fail	Overall Compliance: No
			Severity Score: 18.75

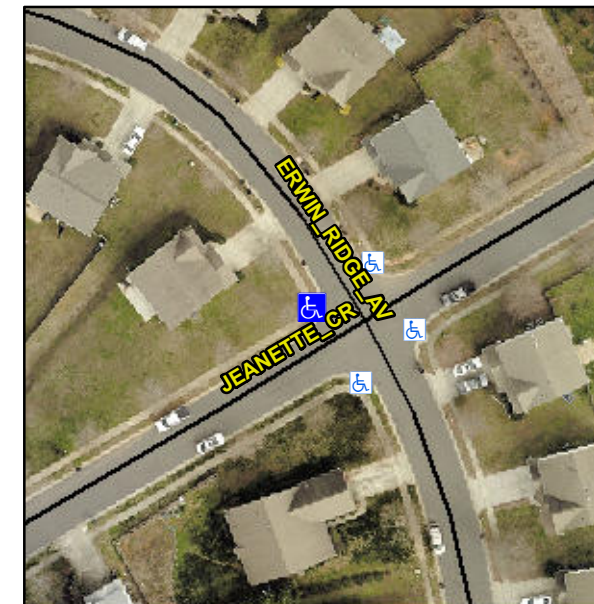
Compliance	Description	Data	Compliance	Description	Data
N/A	Ramp Length (in)	46.0	Yes	Ramp Slope (%)	6.2
No	Ramp Width (in)	35.5	No	Ramp XSlope (%)	3.0
N/A	Flare Type LT	N/A	N/A	Flare Type RT	N/A
N/A	Flare Slope LT (%)	N/A	N/A	Flare Slope RT (%)	N/A
N/A	Flare Traversable LT?	N/A	N/A	Flare Traversable RT?	N/A
N/A	Landing Length (in)	N/A	N/A	DWS Provided?	N/A
N/A	Landing Width (in)	N/A	N/A	DWS Contrast?	N/A
N/A	Landing Slope (%)	N/A	N/A	DWS Length (in)	N/A
N/A	Landing X Slope (%)	N/A	N/A	DWS Full Width?	N/A
N/A	Landing Curb? (Y/N)	N/A	N/A	DWS Offset (in)	N/A
N/A	Shared Landing?	N/A			
N/A	Gutter Ponding?	N/A	N/A	Gutter Slope (%)	N/A
N/A	Gutter Lip Ht (in)	N/A	N/A	Gutter X Slope (%)	N/A
N/A	Painted X Walk1?	No	N/A	Painted X Walk2?	No
	X Walk 1 Direction	To S		X Walk 2 Direction	To E
N/A	X Walk 1 Width (in)	N/A	N/A	X Walk 2 Width (in)	N/A
	X Walk 1 Slope (%)	0.7		X Walk 2 Slope (%)	4.3
	X Walk 1 X Slope (%)	3.8		X Walk 2 X Slope (%)	0.9

N/A	Ramp inside XWalk1?	N/A	N/A	Ramp inside XWalk2?	N/A
	Road Slope (%)	3.3	N/A	Clear Space?	N/A
	Road X Slope (%)	1.8	N/A	Clear Space to XWalk (in)	N/A
N/A	Any Obstructions?	N/A	N/A	Storm Grate/Utility Hazard?	N/A
	Obstruction Type			Storm Grate/Utility Type	
		N/A			N/A
		Yes		Surface Condition? (G/P)	Good

Remove & Replace Curb Ramp With Two New Directional Ramps or Equivalent.

Not Found, R304.5.1, R304.5.3
