Access Compliance Report

Public Rights-of-Way

(Curb Ramps)

Intersection ID: N/A	Main Street: 24TH_ST	Cross Street: N/A	Location: E
ADA ID: C92CA2C30767	Ramp Type: ParaDiag	Initial Pass/Fail: Fail	Overall Compliance: No
		Severity Score: 25

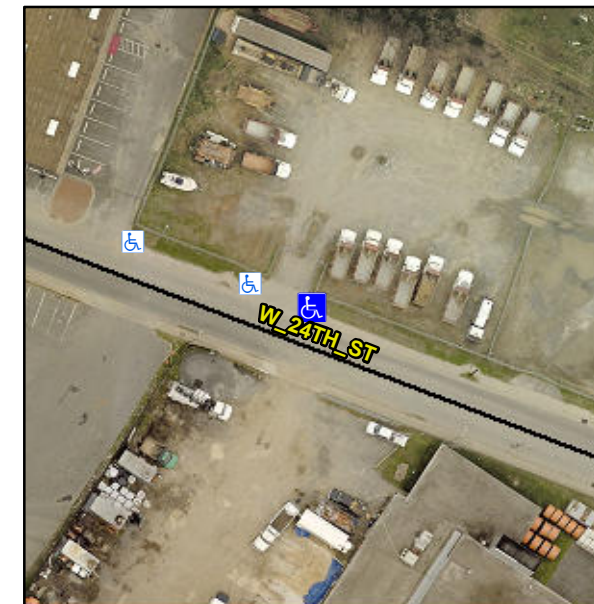
Compliance	Description	Data	Compliance	Description	Data
N/A	Ramp Length LT (in)	40.0	N/A	Ramp Length RT (in)	50.0
Yes	Ramp Width LT (in)	60.0	Yes	Ramp Width RT (in)	60.0
No	Ramp Slope LT (%)	9.1	Yes	Ramp Slope RT (%)	7.4
No	Ramp XSlope LT (%)	5.6	Yes	Ramp XSlope RT (%)	1.6
N/A	Landing Length (in)	N/A	N/A	DWS Provided?	N/A
N/A	Landing Width (in)	N/A	N/A	DWS Contrast?	N/A
N/A	Landing Slope (%)	N/A	N/A	DWS Length (in)	N/A
N/A	Landing X Slope (%)	N/A	N/A	DWS Full Width?	N/A
N/A	Landing Curb? (Y/N)	N/A	N/A	DWS Offset (in)	N/A
N/A	Shared Landing?	N/A			
N/A	Gutter Ponding?	N/A	N/A	Gutter Slope (%)	N/A
N/A	Gutter Lip Ht (in)	N/A	N/A	Gutter X Slope (%)	N/A
N/A	Painted X Walk1?	No	N/A	Painted X Walk2?	No
	X Walk 1 Direction	To NW		X Walk 2 Direction	To SW
N/A	X Walk 1 Width (in)	N/A	N/A	X Walk 2 Width (in)	N/A
	X Walk 1 Slope (%)	2.7		X Walk 2 Slope (%)	0.7
	X Walk 1 X Slope (%)	0.8		X Walk 2 X Slope (%)	0.3
N/A	Ramp inside XWalk1?	N/A	N/A	Ramp inside XWalk2?	N/A

Road Slope (%)	0.2	N/A	Clear Space?	N/A
	Road X Slope (%)	0.2	N/A	Clear Space to XWalk (in)	N/A
N/A	Any Obstructions?	N/A	N/A	Storm Grate/Utility Hazard?	N/A
	Obstruction Type			Storm Grate/Utility Type	
		N/A			N/A
			Yes	Surface Condition? (G/P)	Good
			N/A	Curb Slope (%)	13.7

Remove & Replace Curb Ramp With Two New Directional Ramps or Equivalent.

R304.3.2, R304.5.3
