Access Compliance Report

Public Rights-of-Way

(Curb Ramps)

Intersection ID: 15375	Main Street: FUGATE_AV	Cross Street: MONROE_RD	Location:	N
ADA ID: C9450B0C9307	Ramp Type: Perp	Initial Pass/Fail: Fail	Overall Compliance: No	Severity Score: 8.75

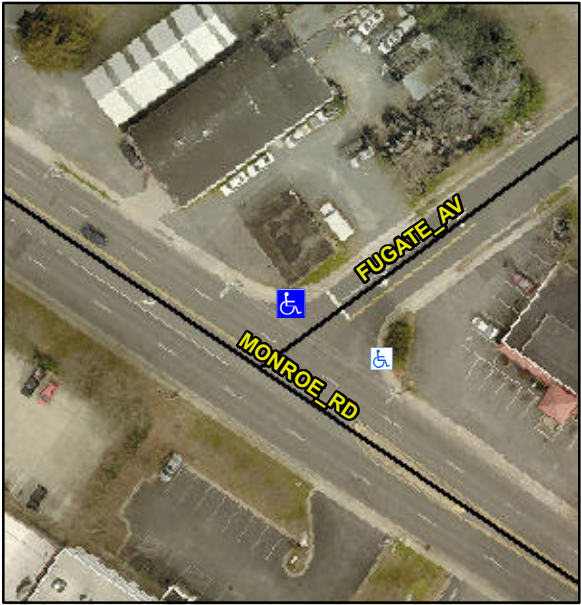
Possible Solutions:		Compliance	Description	Data
	Remove & Replace Entire Ramp.		N/A	Ramp Length (in)	49.0
			No	Ramp Width (in)	45.5
			N/A	Flare Type LT	N/A
			N/A	Flare Slope LT (%)	N/A
			N/A	Flare Traversable LT?	N/A
			N/A	Landing Length (in)	N/A
			N/A	Landing Width (in)	N/A
			N/A	Landing Slope (%)	N/A
			N/A	Landing X Slope (%)	N/A
<p>Surveyor Notes:</p> <p>N/A</p> <p>PROW/ADA:</p> <p>Not Found, R304.5.1</p>			N/A	Flare Type RT	N/A
			N/A	Flare Slope RT (%)	N/A
			N/A	Flare Traversable RT?	N/A
			N/A	DWS Provided?	N/A
			N/A	DWS Contrast?	N/A
			N/A	DWS Length (in)	N/A
			N/A	DWS Full Width?	N/A
			N/A	DWS Offset (in)	N/A
			N/A	Shared Landing?	N/A
			N/A	Gutter Ponding?	N/A
			N/A	Gutter Lip Ht (in)	0.5
			N/A	Painted X Walk1?	No
				X Walk 1 Direction	To SE
			N/A	X Walk 1 Width (in)	N/A
				X Walk 1 Slope (%)	0.9
				X Walk 1 X Slope (%)	2.4

N/A	Ramp inside XWalk1?	N/A
			N/A	Road Slope (%)	N/A
			N/A	Road X Slope (%)	N/A
			N/A	Any Obstructions?	N/A
				Obstruction Type	
			N/A		N/A
			Yes	Surface Condition? (G/P)	Good
