Access Compliance Report

Public Rights-of-Way

(Curb Ramps)

Intersection ID: 2761	Main Street: BEAUVISTA_DR	Cross Street: MAPLE_COVE_LN	Location: SE
ADA ID: C94676826A0A	Ramp Type: PerpDiag	Initial Pass/Fail: Fail	Overall Compliance: No
Severity Score: 13.75			
Codes/Mitigation Info/Possible Solution		Field Measurements/Component Compliance

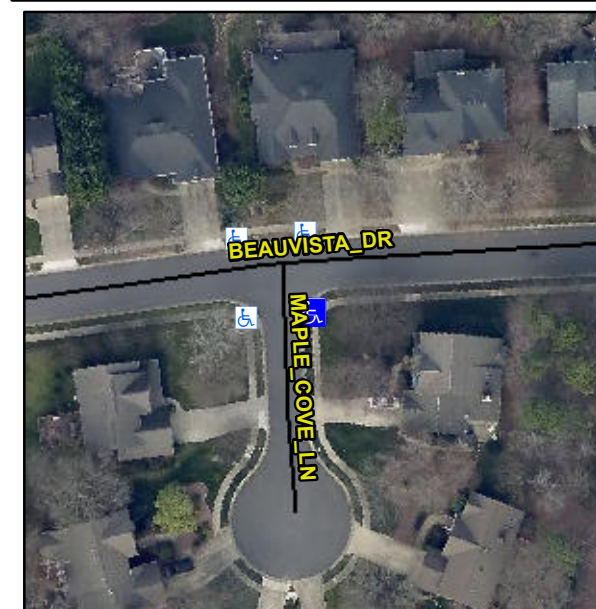
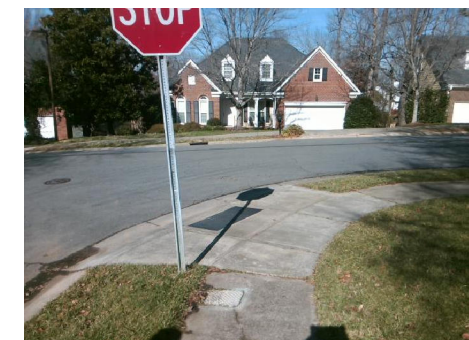
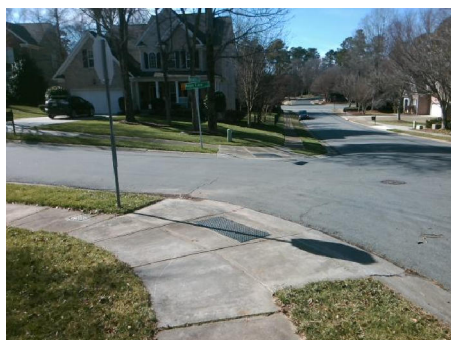
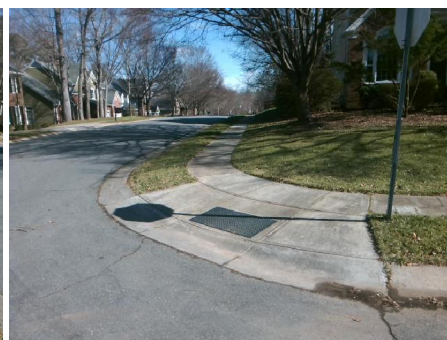
Not Found, R304.2.2, R304.5.3

Compliance	Description	Data	Compliance	Description	Data
N/A	Ramp Length (in)	50.5	No	Ramp Slope (%)	10.8
Yes	Ramp Width (in)	52.0	No	Ramp XSlope (%)	2.4
N/A	Flare Type LT	N/A	N/A	Flare Type RT	N/A
N/A	Flare Slope LT (%)	N/A	N/A	Flare Slope RT (%)	N/A
N/A	Flare Traversable LT?	N/A	N/A	Flare Traversable RT?	N/A
N/A	Landing Length (in)	N/A	N/A	DWS Provided?	N/A
N/A	Landing Width (in)	N/A	N/A	DWS Contrast?	N/A
N/A	Landing Slope (%)	N/A	N/A	DWS Length (in)	N/A
N/A	Landing X Slope (%)	N/A	N/A	DWS Full Width?	N/A
N/A	Landing Curb? (Y/N)	N/A	N/A	DWS Offset (in)	N/A
N/A	Shared Landing?	N/A			
N/A	Gutter Ponding?	N/A	N/A	Gutter Slope (%)	N/A
N/A	Gutter Lip Ht (in)	N/A	N/A	Gutter X Slope (%)	N/A
N/A	Painted X Walk1?	No	N/A	Painted X Walk2?	No
	X Walk 1 Direction	To N		X Walk 2 Direction	To W
N/A	X Walk 1 Width (in)	N/A	N/A	X Walk 2 Width (in)	N/A
	X Walk 1 Slope (%)	0.7		X Walk 2 Slope (%)	4.0
	X Walk 1 X Slope (%)	5.2		X Walk 2 X Slope (%)	3.8

N/A	Ramp inside XWalk1?	N/A	N/A	Ramp inside XWalk2?	N/A
	Road Slope (%)	3.1	N/A	Clear Space?	N/A
	Road X Slope (%)	2.6	N/A	Clear Space to XWalk (in)	N/A
N/A	Any Obstructions?	N/A	N/A	Storm Grate/Utility Hazard?	N/A
	Obstruction Type			Storm Grate/Utility Type	
		N/A			N/A
			Yes	Surface Condition? (G/P)	Good

Remove & Replace Curb Ramp With Two New Directional Ramps or Equivalent.
