Access Compliance Report

Public Rights-of-Way

(Curb Ramps)

Intersection ID: 10510	Main Street: COXE_AV	Cross Street: WHITEHAVEN_AV	Location:	N
ADA ID: C94F39B2D2F7	Ramp Type: Perp	Initial Pass/Fail: Fail	Overall Compliance: No	Severity Score: 35

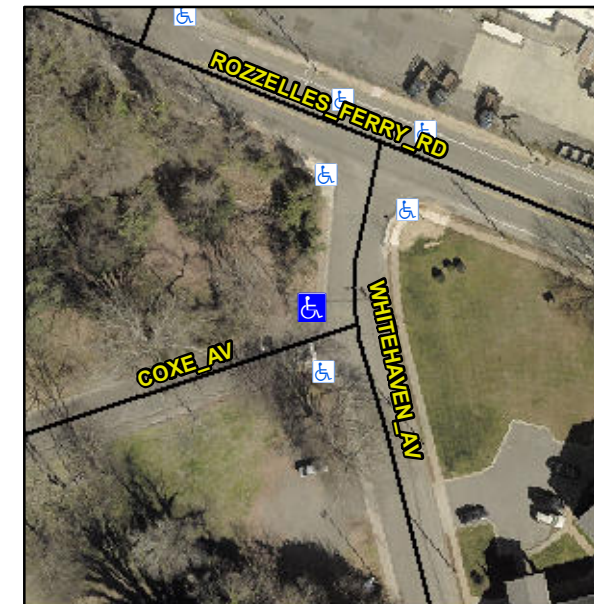
Not Found, R304.5.1, R304.2.2, R304.5.3

Compliance	Description	Data	Compliance	Description	Data
N/A	Ramp Length (in)	46.0	No	Ramp Slope (%)	15.5
No	Ramp Width (in)	39.0	No	Ramp XSlope (%)	2.2
N/A	Flare Type LT	N/A	N/A	Flare Type RT	N/A
N/A	Flare Slope LT (%)	N/A	N/A	Flare Slope RT (%)	N/A
N/A	Flare Traversable LT?	N/A	N/A	Flare Traversable RT?	N/A
N/A	Landing Length (in)	N/A	N/A	DWS Provided?	N/A
N/A	Landing Width (in)	N/A	N/A	DWS Contrast?	N/A
N/A	Landing Slope (%)	N/A	N/A	DWS Length (in)	N/A
N/A	Landing X Slope (%)	N/A	N/A	DWS Full Width?	N/A
N/A	Landing Curb? (Y/N)	N/A	N/A	DWS Offset (in)	N/A
N/A	Shared Landing?	N/A			
N/A	Gutter Ponding?	N/A	N/A	Gutter Slope (%)	N/A
N/A	Gutter Lip Ht (in)	0.5	N/A	Gutter X Slope (%)	N/A
N/A	Painted X Walk1?	No	N/A	Painted X Walk2?	N/A
	X Walk 1 Direction	To S		X Walk 2 Direction	N/A
N/A	X Walk 1 Width (in)	N/A	N/A	X Walk 2 Width (in)	N/A
	X Walk 1 Slope (%)	5.3		X Walk 2 Slope (%)	N/A
	X Walk 1 X Slope (%)	4.3		X Walk 2 X Slope (%)	N/A

Remove & Replace Entire Ramp.
