Intersection ID: 16569	Main Street: FOREST_PARK_DR	Cross Street: PRINCETON_AV	Location:	NW
ADA ID: C954591E6A6D	Ramp Type: ParaDiag	Initial Pass/Fail: Fail	Overall Compliance: No	Severity Score: 26.25

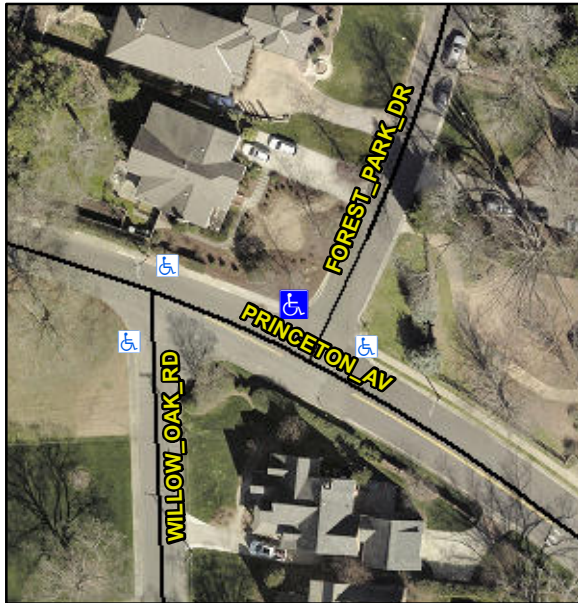
Compliance	Description	Data	Compliance	Description	Data
N/A	Ramp Length LT (in)	33.0	N/A	Ramp Length RT (in)	40.0
Yes	Ramp Width LT (in)	49.0	Yes	Ramp Width RT (in)	50.0
No	Ramp Slope LT (%)	14.5	No	Ramp Slope RT (%)	10.3
No	Ramp XSlope LT (%)	4.0	No	Ramp XSlope RT (%)	4.1
N/A	Landing Length (in)	N/A	N/A	DWS Provided?	N/A
N/A	Landing Width (in)	N/A	N/A	DWS Contrast?	N/A
N/A	Landing Slope (%)	N/A	N/A	DWS Length (in)	N/A
N/A	Landing X Slope (%)	N/A	N/A	DWS Full Width?	N/A
N/A	Landing Curb? (Y/N)	N/A	N/A	DWS Offset (in)	N/A
N/A	Shared Landing?	N/A			
N/A	Gutter Ponding?	N/A	N/A	Gutter Slope (%)	N/A
N/A	Gutter Lip Ht (in)	N/A	N/A	Gutter X Slope (%)	N/A
N/A	Painted X Walk1?	No	N/A	Painted X Walk2?	No
	X Walk 1 Direction	To SW		X Walk 2 Direction	To SE
N/A	X Walk 1 Width (in)	N/A	N/A	X Walk 2 Width (in)	N/A
	X Walk 1 Slope (%)	8.4		X Walk 2 Slope (%)	2.3
	X Walk 1 X Slope (%)	3.8		X Walk 2 X Slope (%)	12.2
N/A	Ramp inside XWalk1?	N/A	N/A	Ramp inside XWalk2?	N/A

Road Slope (%)	10.3	N/A	Clear Space?	N/A
	Road X Slope (%)	5.1	N/A	Clear Space to XWalk (in)	N/A
N/A	Any Obstructions?	N/A	N/A	Storm Grate/Utility Hazard?	N/A
	Obstruction Type			Storm Grate/Utility Type	
		N/A			N/A
			Yes	Surface Condition? (G/P)	Good
			N/A	Curb Slope (%)	6.5

Remove & Replace Curb Ramp With Two New Directional Ramps or Equivalent.
