Access Compliance Report Public Rights-of-Way (Curb Ramps)

Intersection ID: 48196 Main Street: BLAKENEY_PARK_DR Cross Street: REA_RD Location: W

ADA ID: C957723D3484 Ramp Type: PerpDiag Initial Pass/Fail: Fail Overall Compliance: No Severity Score: 22.5

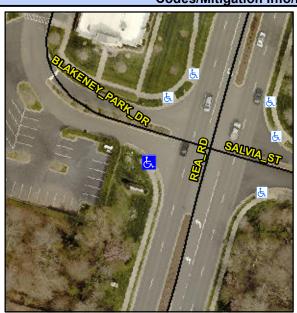
Street 1 Name REA RD
Stop Condition-Street 2 None
Street 2 Name BLAKENEY PARK DR
Stop Condition-Street 1 StopSign

Not Found, R304.5.1, R304.2.2, R304.5.3

Remove & Replace Curb Ramp With Two New Directional Ramps or Equivalent.
