# Access Compliance Report

## Public Rights-of-Way

### (Curb Ramps)

| Intersection ID: 10022675 | Main Street: CARNEGIE_BV | Cross Street: N/A | Location: S |

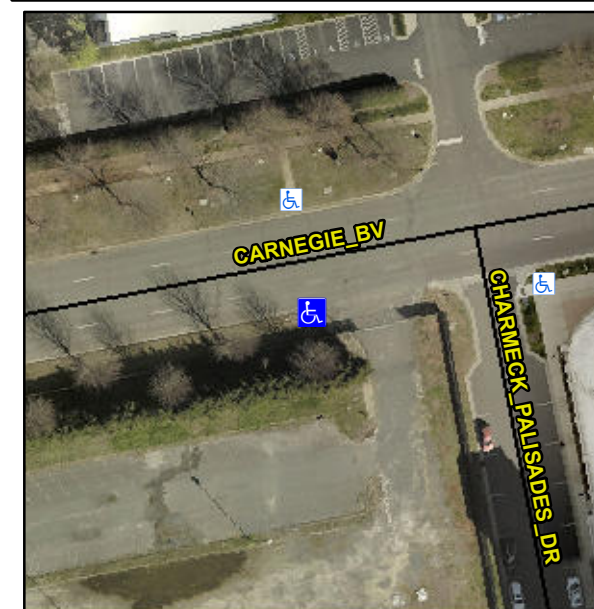
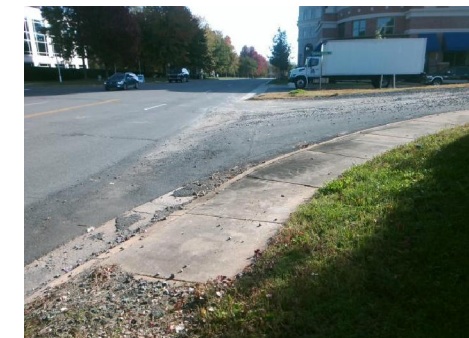
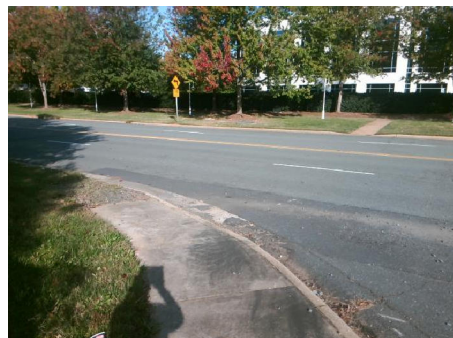
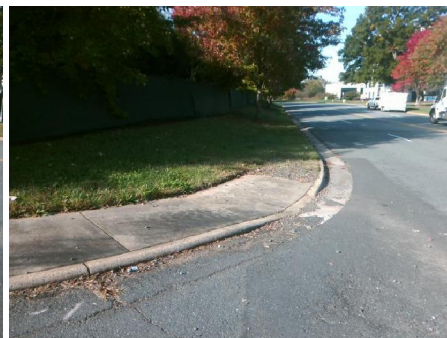
**Not Found, R304.2.2**

| Compliance | Description | Data | Compliance | Description | Data |
|---|---|---|---|---|---|
| N/A | Ramp Length (in) | 60.0 | No | Ramp Slope (%) | 12.8 |

**Remove & Replace Entire Ramp.**
