Access Compliance Report

Public Rights-of-Way

(Curb Ramps)

Intersection ID: 45153	Main Street: REID_MEADOWS_DR	Cross Street: REID_OAKS_DR	Location: NW
ADA ID: C960D1A7E983	Ramp Type: PerpDiag	Initial Pass/Fail: Fail	Overall Compliance: No
Severity Score: 10			
Codes/Mitigation Info/Possible Solution		Field Measurements/Component Compliance

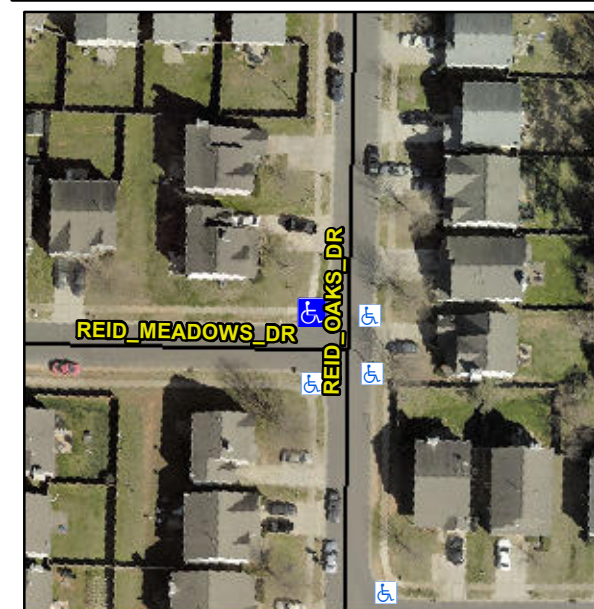
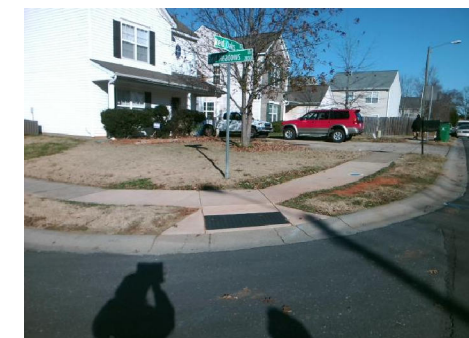
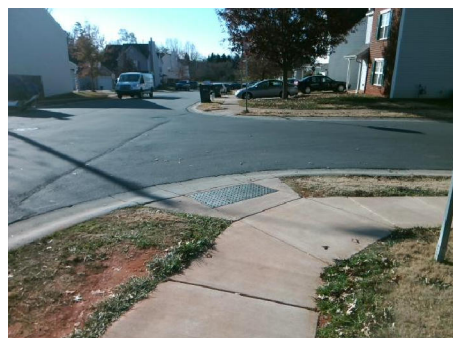
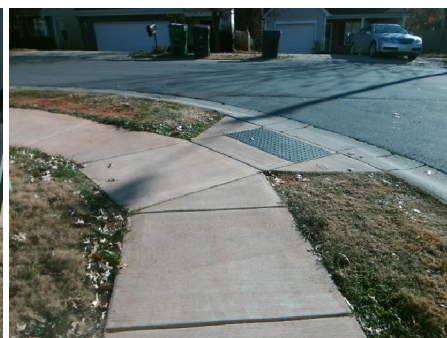
Not Found, R304.5.1, R304.5.3

Compliance	Description	Data	Compliance	Description	Data
N/A	Ramp Length (in)	45.0	Yes	Ramp Slope (%)	6.0
No	Ramp Width (in)	47.5	No	Ramp XSlope (%)	4.9
N/A	Flare Type LT	N/A	N/A	Flare Type RT	N/A
N/A	Flare Slope LT (%)	N/A	N/A	Flare Slope RT (%)	N/A
N/A	Flare Traversable LT?	N/A	N/A	Flare Traversable RT?	N/A
N/A	Landing Length (in)	N/A	N/A	DWS Provided?	N/A
N/A	Landing Width (in)	N/A	N/A	DWS Contrast?	N/A
N/A	Landing Slope (%)	N/A	N/A	DWS Length (in)	N/A
N/A	Landing X Slope (%)	N/A	N/A	DWS Full Width?	N/A
N/A	Landing Curb? (Y/N)	N/A	N/A	DWS Offset (in)	N/A
N/A	Shared Landing?	N/A			
N/A	Gutter Ponding?	N/A	N/A	Gutter Slope (%)	N/A
N/A	Gutter Lip Ht (in)	N/A	N/A	Gutter X Slope (%)	N/A
N/A	Painted X Walk1?	No	N/A	Painted X Walk2?	No
	X Walk 1 Direction	To S		X Walk 2 Direction	To E
N/A	X Walk 1 Width (in)	N/A	N/A	X Walk 2 Width (in)	N/A
	X Walk 1 Slope (%)	1.9		X Walk 2 Slope (%)	4.9
	X Walk 1 X Slope (%)	4.4		X Walk 2 X Slope (%)	5.5

N/A	Ramp inside XWalk1?	N/A	N/A	Ramp inside XWalk2?	N/A
	Road Slope (%)	6.7	N/A	Clear Space?	N/A
	Road X Slope (%)	1.6	N/A	Clear Space to XWalk (in)	N/A
N/A	Any Obstructions?	N/A	N/A	Storm Grate/Utility Hazard?	N/A
	Obstruction Type			Storm Grate/Utility Type	
		N/A			N/A
		Yes		Surface Condition? (G/P)	Good

Remove & Replace Curb Ramp With Two New Directional Ramps or Equivalent.
