Intersection ID: 42944	Main Street: TURNING_WHEEL_DR	Cross Street: SONOMA_VALLEY_DR	Location:	SE
ADA ID: C978064FEAC9	Ramp Type: PerpDiag	Initial Pass/Fail: Fail	Overall Compliance: No	Severity Score: 10

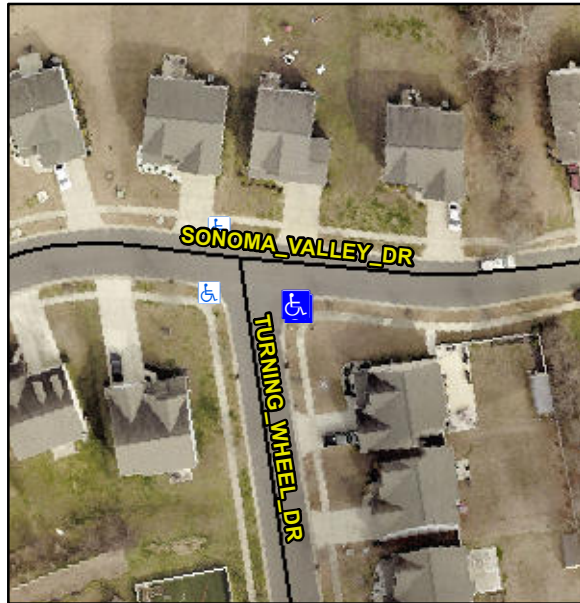
Not Found, R304.5.1, R304.5.3

Compliance	Description	Data	Compliance	Description	Data
N/A	Ramp Length (in)	70.5	Yes	Ramp Slope (%)	5.0
No	Ramp Width (in)	47.0	No	Ramp XSlope (%)	4.5
N/A	Flare Type LT	N/A	N/A	Flare Type RT	N/A
N/A	Flare Slope LT (%)	N/A	N/A	Flare Slope RT (%)	N/A
N/A	Flare Traversable LT?	N/A	N/A	Flare Traversable RT?	N/A
N/A	Landing Length (in)	N/A	N/A	DWS Provided?	N/A
N/A	Landing Width (in)	N/A	N/A	DWS Contrast?	N/A
N/A	Landing Slope (%)	N/A	N/A	DWS Length (in)	N/A
N/A	Landing X Slope (%)	N/A	N/A	DWS Full Width?	N/A
N/A	Landing Curb? (Y/N)	N/A	N/A	DWS Offset (in)	N/A
N/A	Shared Landing?	N/A			
N/A	Gutter Ponding?	N/A	N/A	Gutter Slope (%)	N/A
N/A	Gutter Lip Ht (in)	N/A	N/A	Gutter X Slope (%)	N/A
N/A	Painted X Walk1?	No	N/A	Painted X Walk2?	No
	X Walk 1 Direction	To N		X Walk 2 Direction	To W
N/A	X Walk 1 Width (in)	N/A	N/A	X Walk 2 Width (in)	N/A
	X Walk 1 Slope (%)	3.7		X Walk 2 Slope (%)	0.2
	X Walk 1 X Slope (%)	1.7		X Walk 2 X Slope (%)	0.5

N/A	Ramp inside XWalk1?	N/A	N/A	Ramp inside XWalk2?	N/A
	Road Slope (%)	2.1	N/A	Clear Space?	N/A
	Road X Slope (%)	1.1	N/A	Clear Space to XWalk (in)	N/A
N/A	Any Obstructions?	N/A	N/A	Storm Grate/Utility Hazard?	N/A
	Obstruction Type			Storm Grate/Utility Type	
		N/A			N/A
			Yes	Surface Condition? (G/P)	Good

Remove & Replace Curb Ramp With Two New Directional Ramps or Equivalent.

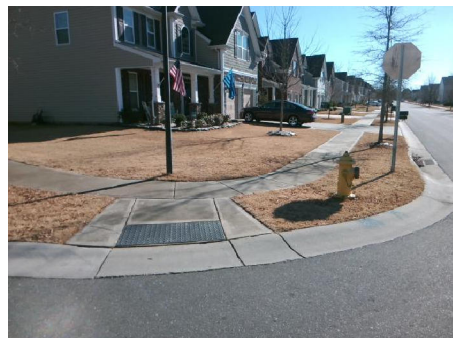
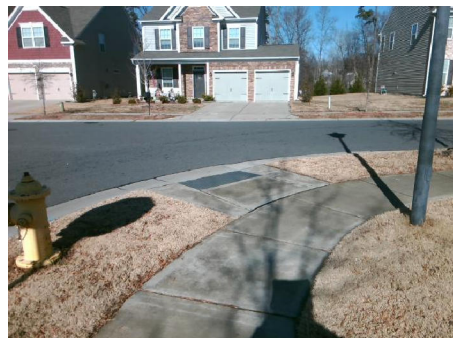
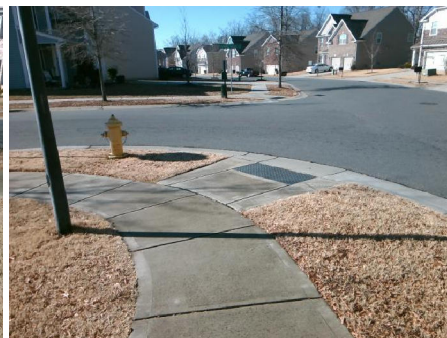
Street 1 Name	SONOMA VALLEY DR
Stop Condition-Street 2	None
Street 2 Name	TURNING WHEEL DR
Stop Condition-Street 1	StopSign
