Access Compliance Report

Public Rights-of-Way

(Curb Ramps)

Intersection ID: 47692	Main Street: AMBER_MEADOWS_DR	Cross Street: GLENOLDEN_DR	Location: E
ADA ID: C9781DAFAD40	Ramp Type: Perp	Initial Pass/Fail: Fail	Overall Compliance: No
Severity Score: 33.75			
Codes/Mitigation Info/Possible Solution		Field Measurements/Component Compliance

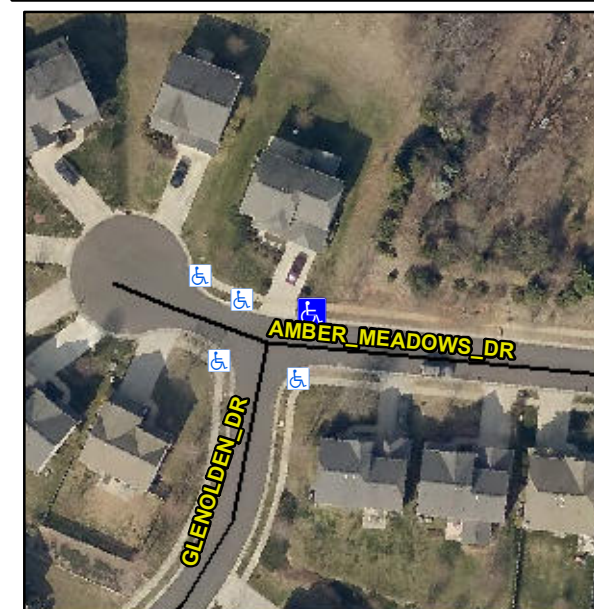
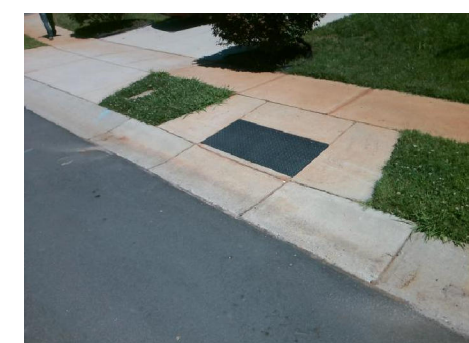
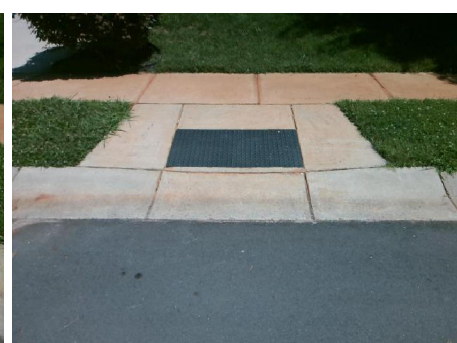
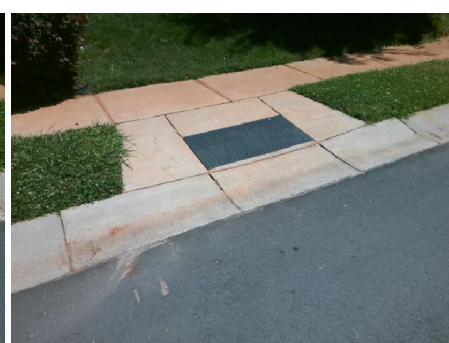
Not Found, R304.5.1, R304.2.2

Compliance	Description	Data	Compliance	Description	Data
N/A	Ramp Length (in)	48.0	No	Ramp Slope (%)	13.5
No	Ramp Width (in)	47.0	Yes	Ramp XSlope (%)	1.3
N/A	Flare Type LT	N/A	N/A	Flare Type RT	N/A
N/A	Flare Slope LT (%)	N/A	N/A	Flare Slope RT (%)	N/A
N/A	Flare Traversable LT?	N/A	N/A	Flare Traversable RT?	N/A
N/A	Landing Length (in)	N/A	N/A	DWS Provided?	N/A
N/A	Landing Width (in)	N/A	N/A	DWS Contrast?	N/A
N/A	Landing Slope (%)	N/A	N/A	DWS Length (in)	N/A
N/A	Landing X Slope (%)	N/A	N/A	DWS Full Width?	N/A
N/A	Landing Curb? (Y/N)	N/A	N/A	DWS Offset (in)	N/A
N/A	Shared Landing?	N/A			
N/A	Gutter Ponding?	N/A	N/A	Gutter Slope (%)	N/A
N/A	Gutter Lip Ht (in)	N/A	N/A	Gutter X Slope (%)	N/A
N/A	Painted X Walk1?	No	N/A	Painted X Walk2?	N/A
	X Walk 1 Direction	To S		X Walk 2 Direction	N/A
N/A	X Walk 1 Width (in)	N/A	N/A	X Walk 2 Width (in)	N/A
	X Walk 1 Slope (%)	1.6		X Walk 2 Slope (%)	N/A
	X Walk 1 X Slope (%)	2.8		X Walk 2 X Slope (%)	N/A

N/A	Ramp inside XWalk1?	N/A	N/A	Ramp inside XWalk2?	N/A
	Road Slope (%)	N/A	N/A	Clear Space?	N/A
	Road X Slope (%)	N/A	N/A	Clear Space to XWalk (in)	N/A
N/A	Any Obstructions?	N/A	N/A	Storm Grate/Utility Hazard?	N/A
	Obstruction Type			Storm Grate/Utility Type	
		N/A			N/A
			Yes	Surface Condition? (G/P)	Good

Remove & Replace Entire Ramp.
