# Access Compliance Report

## Public Rights-of-Way

### (Curb Ramps)

Intersection ID: 42752	Main Street: ASHLEY_MEADOW_DR	Cross Street: SAWMILL_TRACE_DR	Location: S
ADA ID: C979AF5FB3A9	Ramp Type: PerpDiag	Initial Pass/Fail: Fail	Overall Compliance: No
Severity Score: 10			
Codes/Mitigation Info/Possible Solution		Field Measurements/Component Compliance

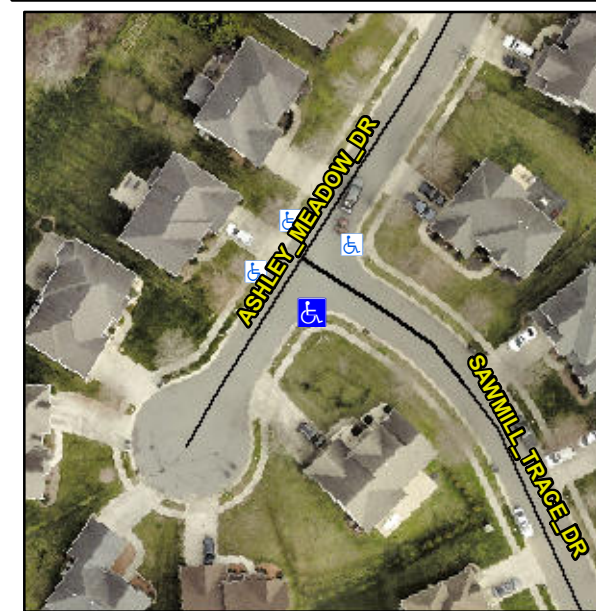
**Not Found, R304.5.1, R304.5.3**

Compliance	Description	Data	Compliance	Description	Data
N/A	Ramp Length (in)	52.0	Yes	Ramp Slope (%)	8.1
No	Ramp Width (in)	47.5	No	Ramp XSlope (%)	2.6
N/A	Flare Type LT	N/A	N/A	Flare Type RT	N/A
N/A	Flare Slope LT (%)	N/A	N/A	Flare Slope RT (%)	N/A
N/A	Flare Traversable LT?	N/A	N/A	Flare Traversable RT?	N/A
N/A	Landing Length (in)	N/A	N/A	DWS Provided?	N/A
N/A	Landing Width (in)	N/A	N/A	DWS Contrast?	N/A
N/A	Landing Slope (%)	N/A	N/A	DWS Length (in)	N/A
N/A	Landing X Slope (%)	N/A	N/A	DWS Full Width?	N/A
N/A	Landing Curb? (Y/N)	N/A	N/A	DWS Offset (in)	N/A
N/A	Shared Landing?	N/A			
N/A	Gutter Ponding?	N/A	N/A	Gutter Slope (%)	N/A
N/A	Gutter Lip Ht (in)	N/A	N/A	Gutter X Slope (%)	N/A
N/A	Painted X Walk1?	No	N/A	Painted X Walk2?	No
	X Walk 1 Direction	To NE		X Walk 2 Direction	To NW
N/A	X Walk 1 Width (in)	N/A	N/A	X Walk 2 Width (in)	N/A
	X Walk 1 Slope (%)	2.7		X Walk 2 Slope (%)	1.8
	X Walk 1 X Slope (%)	0.5		X Walk 2 X Slope (%)	3.7

N/A	Ramp inside XWalk1?	N/A	N/A	Ramp inside XWalk2?	N/A
	Road Slope (%)	1.2	N/A	Clear Space?	N/A
	Road X Slope (%)	5.6	N/A	Clear Space to XWalk (in)	N/A
N/A	Any Obstructions?	N/A	N/A	Storm Grate/Utility Hazard?	N/A
	Obstruction Type			Storm Grate/Utility Type	
		N/A			N/A
		Yes		Surface Condition? (G/P)	Good

**Remove & Replace Curb Ramp With Two New Directional Ramps or Equivalent.**
