# Access Compliance Report

## Public Rights-of-Way

### (Curb Ramps)

Intersection ID: N/A	Main Street: INDEPENDENCE_RD	Cross Street: BUICK_DR	Location: NE
ADA ID: C984259BF07D	Ramp Type: PerpDiag	Initial Pass/Fail: Fail	Overall Compliance: No
Codes/Mitigation Info/Possible Solution			Severity Score: 25
			Field Measurements/Component Compliance

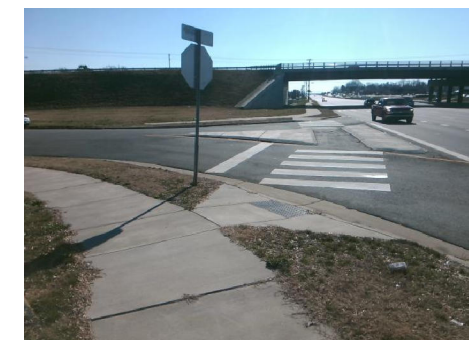
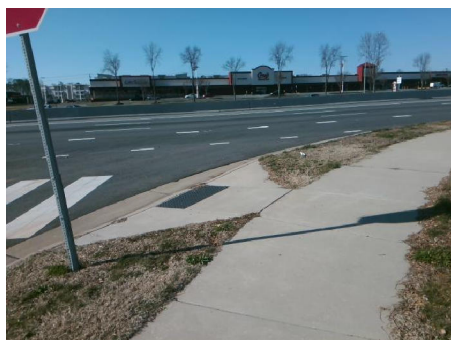
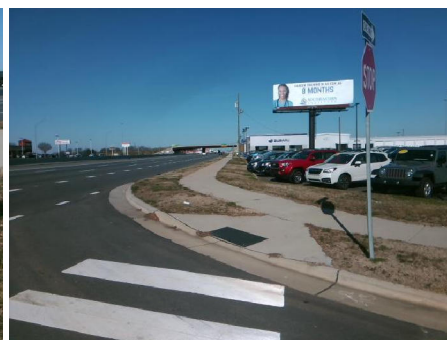
Street 1 Name E INDEPENDENCE BV

Stop Condition-Street 2 None

Street 2 Name BUICK DR

Stop Condition-Street 1 StopSign
