Access Compliance Report

Public Rights-of-Way

(Curb Ramps)

Intersection ID: 46320	Main Street: SHAD_CT	Cross Street: BREWER_DR	Location: SW
ADA ID: C98D6A0DF876	Ramp Type: BlendTrans1	Initial Pass/Fail: Fail	Overall Compliance: No
Codes/Mitigation Info/Possible Solution			Severity Score: 10
			Field Measurements/Component Compliance

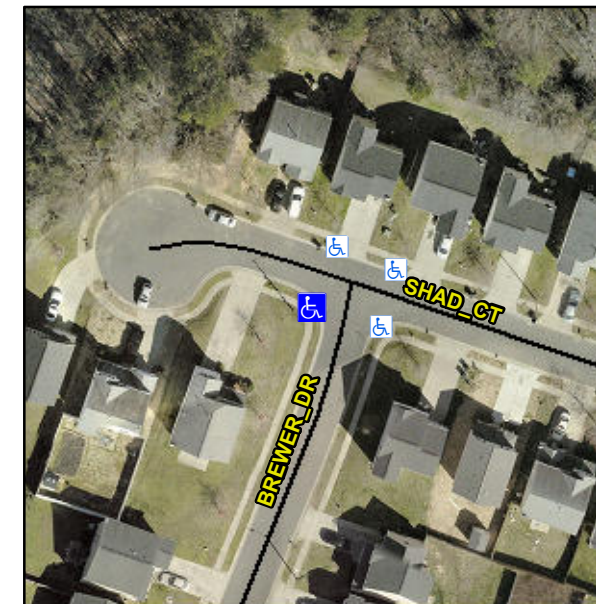
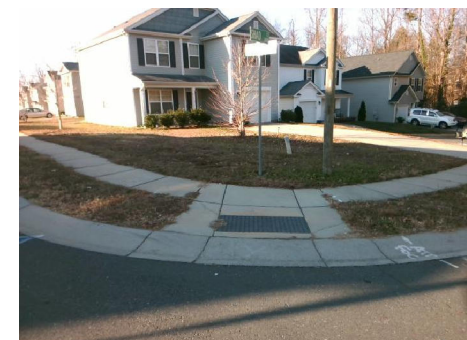
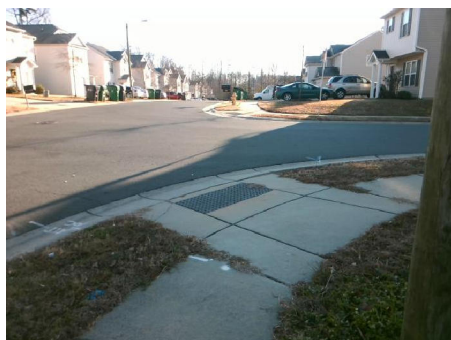
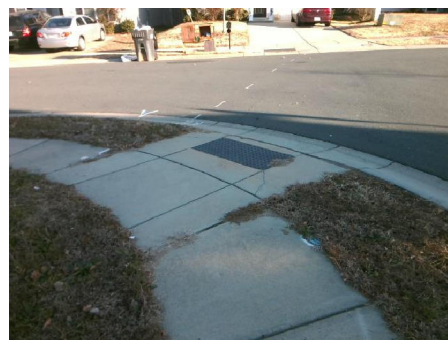
Not Found, R304.5.1, R304.5.3

Compliance	Description	Data	Compliance	Description	Data
N/A	Ramp Length (in)	48.0	Yes	BlendTrans Slope (%)	1.1
No	Ramp Width (in)	47.5	No	BlendTrans XSlope (%)	3.2
N/A	Flare Type LT	N/A	N/A	Flare Type RT	N/A
N/A	Flare Slope LT (%)	N/A	N/A	Flare Slope RT (%)	N/A
N/A	Flare Traversable LT?	N/A	N/A	Flare Traversable RT?	N/A
N/A	Landing Length (in)	N/A	N/A	DWS Provided?	N/A
N/A	Landing Width (in)	N/A	N/A	DWS Contrast?	N/A
N/A	Landing Slope (%)	N/A	N/A	DWS Length (in)	N/A
N/A	Landing X Slope (%)	N/A	N/A	DWS Full Width?	N/A
N/A	Landing Curb? (Y/N)	N/A	N/A	DWS Offset (in)	N/A
N/A	Shared Landing?	N/A			
N/A	Gutter Ponding?	N/A	N/A	Gutter Slope (%)	N/A
N/A	Gutter Lip Ht (in)	N/A	N/A	Gutter X Slope (%)	N/A
N/A	Painted X Walk1?	No	N/A	Painted X Walk2?	No
	X Walk 1 Direction	To E		X Walk 2 Direction	To N
	X Walk 1 Width (in)	N/A		X Walk 2 Width (in)	N/A
	X Walk 1 Slope (%)	7.4		X Walk 2 Slope (%)	2.7
	X Walk 1 X Slope (%)	1.3		X Walk 2 X Slope (%)	5.3

N/A	Ramp inside XWalk1?	N/A	N/A	Ramp inside XWalk2?	N/A
	Road Slope (%)	2.3		Clear Space?	N/A
	Road X Slope (%)	4.4	N/A	Clear Space to XWalk (in)	N/A
N/A	Any Obstructions?	N/A	N/A	Storm Grate/Utility Hazard?	N/A
	Obstruction Type			Storm Grate/Utility Type	
		N/A			N/A
			Yes	Surface Condition? (G/P)	Good
			No	Curb Slope (%)	17.4

Remove & Replace Curb Ramp With Two New Directional Ramps or Equivalent.
