# Access Compliance Report

## Public Rights-of-Way

| Intersection ID: 18769 | Main Street: BARCLAY_DOWNS_DR | Cross Street: RUNNYMEDE_LN | Location: SE |
| ADA ID: C98FFF4E2107 | Ramp Type: Perp | Initial Pass/Fail: Fail | Overall Compliance: No |

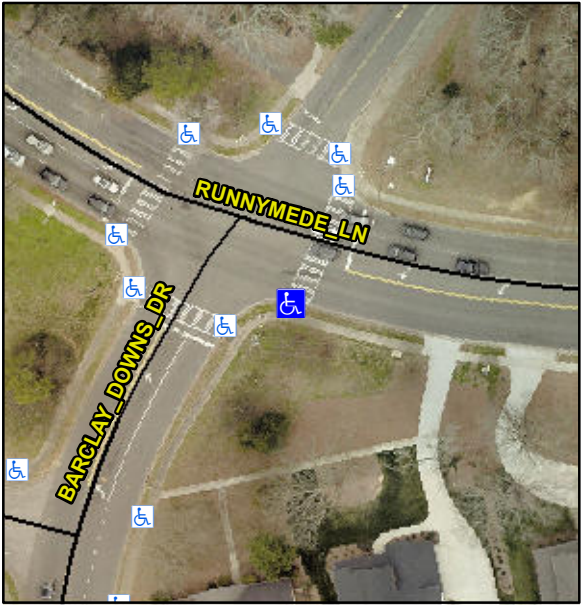
| | | | Severity Score: 13.75 |

| Codes/Mitigation Info/Possible Solution | | | Field Measurements/Component Compliance | | |
|---|---|---|---|---|---|
| | <b>Remove &amp; Replace Entire Ramp.</b> | | <b>No</b> | Ramp Length (in) | 50.0 |
| <p>Surveyor Notes:</p> <p><b>N/A</b></p> <p>PROW/ADA:</p> <p><b>Not Found, R304.2.2</b></p> | | | <b>N/A</b> | Flare Type RT | N/A |

| Codes/Mitigation Info/Possible Solution | | | Field Measurements/Component Compliance | | |
|---|---|---|---|---|---|
| | Possible Solutions: | | <b>Compliance</b> | <b>Description</b> | <b>Data</b> |
